CONSERVATION OF CHINTAMANI MANTAPA AND FORT WALL AT SNANAGHATTA AT ANEGUNDI VILLAGE GANGAVATHI (TALUK) KOPPALA (DISTRICT)

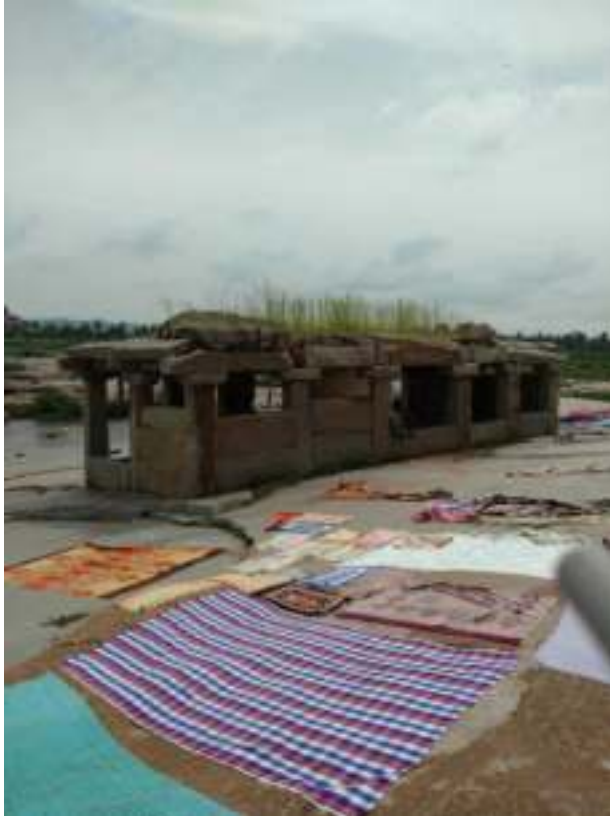
1st Mantapa: The roof should be restored using lime mortar. It helps in preventing water ingress which is presently seen in the soffit of the roof and beams. The roof is the main cause for dampness in the building. The roof needs to be reinstalled and the flagstone roof needs to be re-pointed with lime mortar. The coping needs to be replaced to allow for rainwater to drain effectively from the roof.

Figure 1: Roof of 1st Mantapa needs be restored.

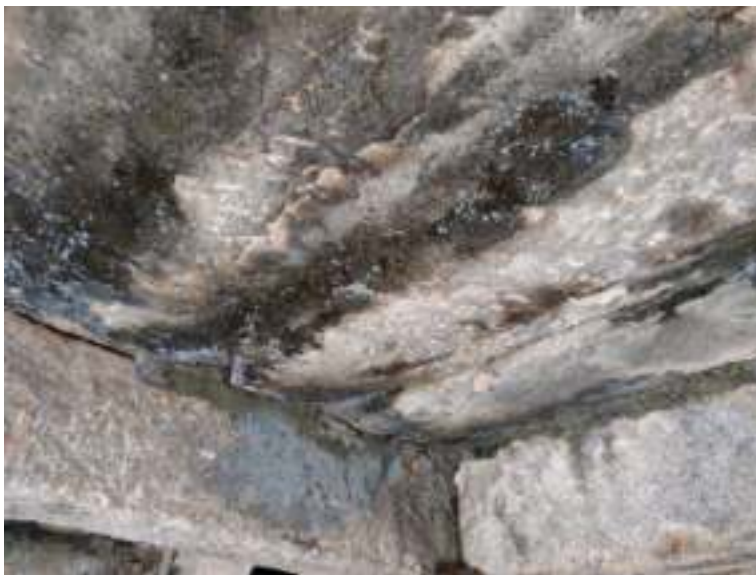
Figure 2: 1st Mantapa, water ingress is seen in the soffit of the roof.

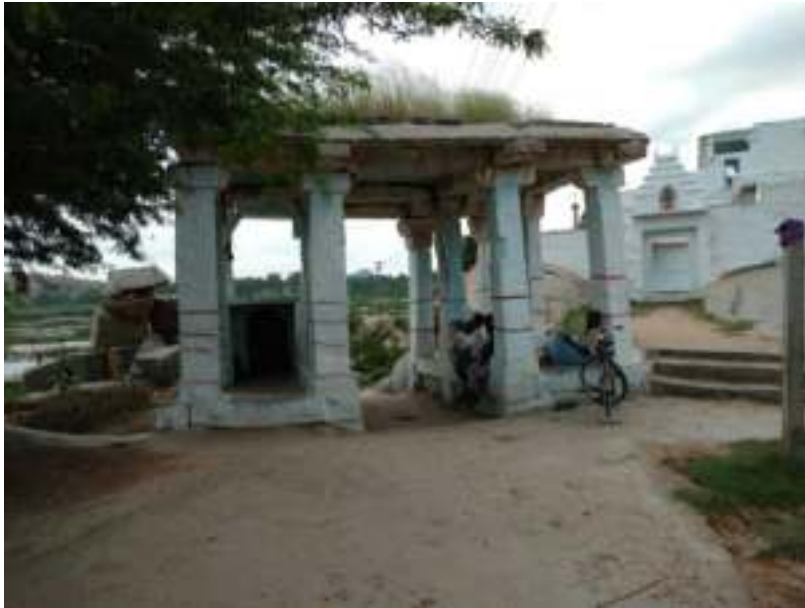
2nd Mantapa: The paint should be removed in the 1st Mantapa, as it is detrimental to the antiquity of the granite. The roof should be reset using lime mortar which helps in preventing dampness.

Figure 3: 2nd Mantapa, the roof needs to be restored.

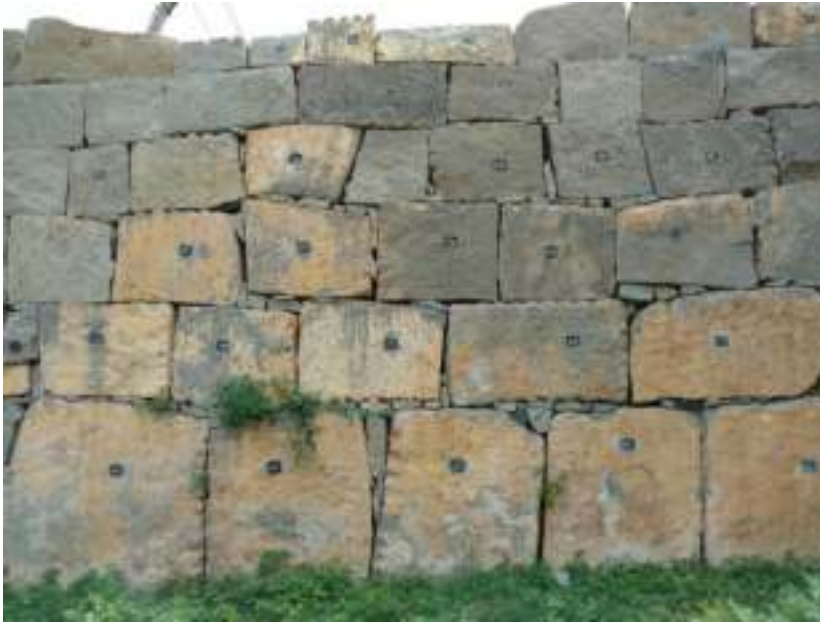
Comments: The numbering to be done with non-abrasive water soluble paint. Avoid numbering that destroys the integrity of the structure (see figure 4).

Figure 4: Numbering as seen on a wall near the North Gate at Aneundi should be avoided.

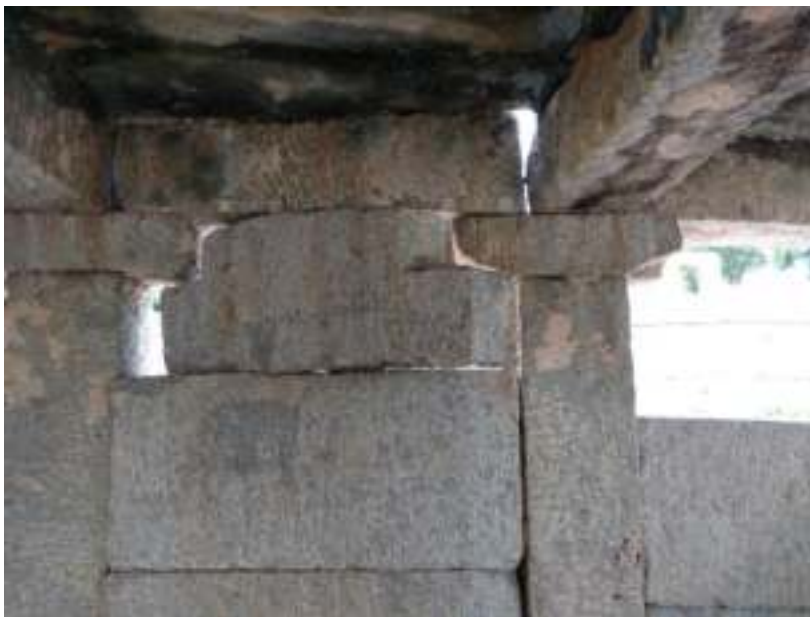
1st Mantapa: The infill stones (seen in figure 5) needs to be realigned. The interior of the Mantapa needs to be cleared of debris and the flooring needs to be raised using lime slurry.

Figure 5: The granite blocks should be restored.

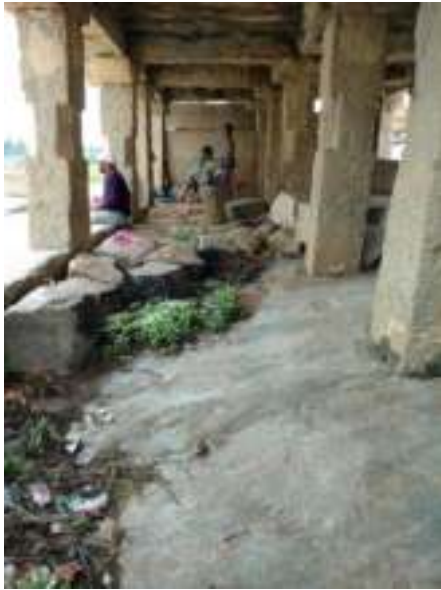
Figure 6: The interiors of the Mantapa need to be cleared and the flooring needs to be raised using flagstones/lime slurry.

2nd Mantapa: The infill fallen masonry needs to be realigned (see figure 6). The roof needs to be restored to prevent any water ingress.

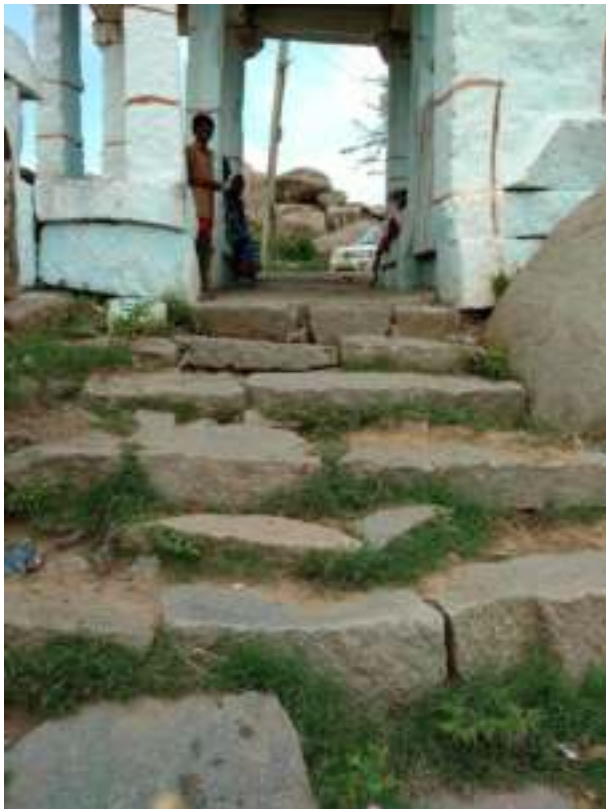
2nd Mantapa: The paint needs to be removed. The flooring needs to be levelled. The approach needs to be reconstructed to allow easy access.

Figure 7: Present condition of the steps. The approach needs to be reconstructed.

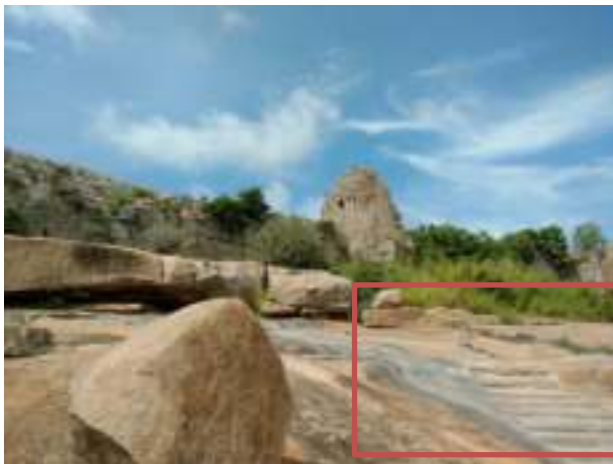
Steps as shown in figure 8 must be avoided as it is irreversible and detrimental to the surrounding setting of the monument.

Figure 8: Approach to the Elephant stable. These kinds of steps that are cut in the bedrock are irreversible and detrimental to the landscape. They should be avoided.

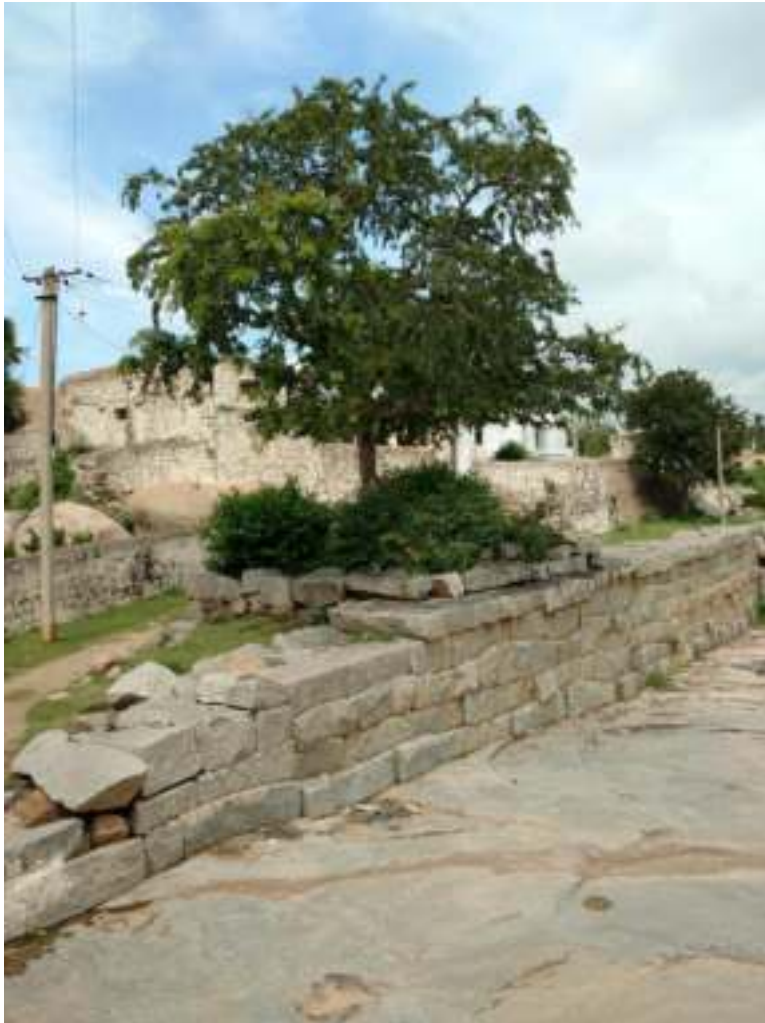
Comments: The numbering to be done with non-abrasive water soluble paint. Avoid numbering that destroys the sanctity of the structure (see figure 4). The fort wall facing the river (river front façade of the fort wall) is in a better condition than the inner façade facing the path. Minimal restoration of the river front façade is sufficient.

Figure 9: River front facade of the fort wall - the facade is in a good condition - minimal restoration required.

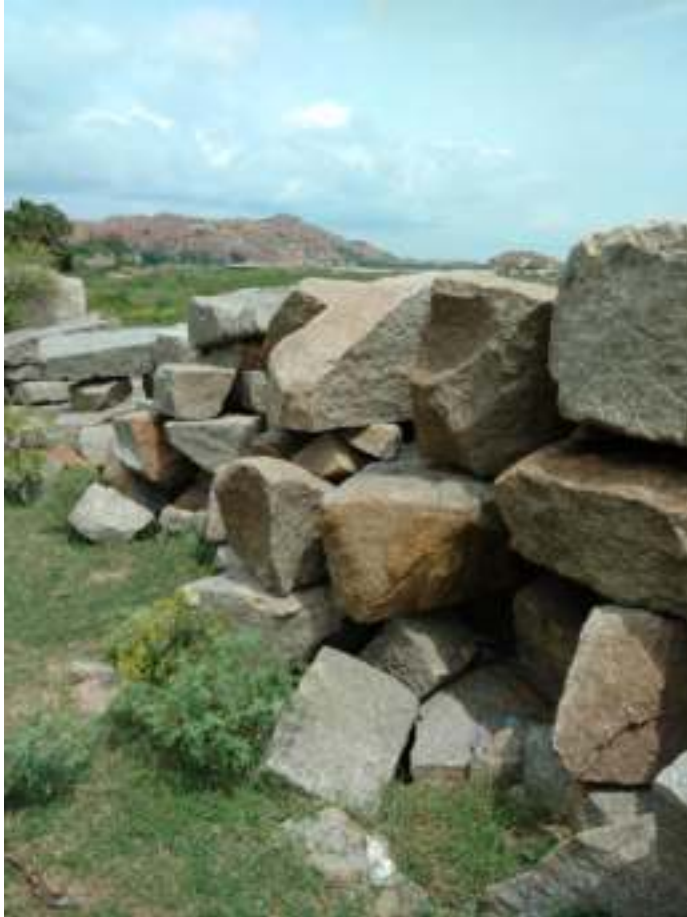
Figure 10: The inner facade of the fort wall requires complete reconstruction with ancient stones.

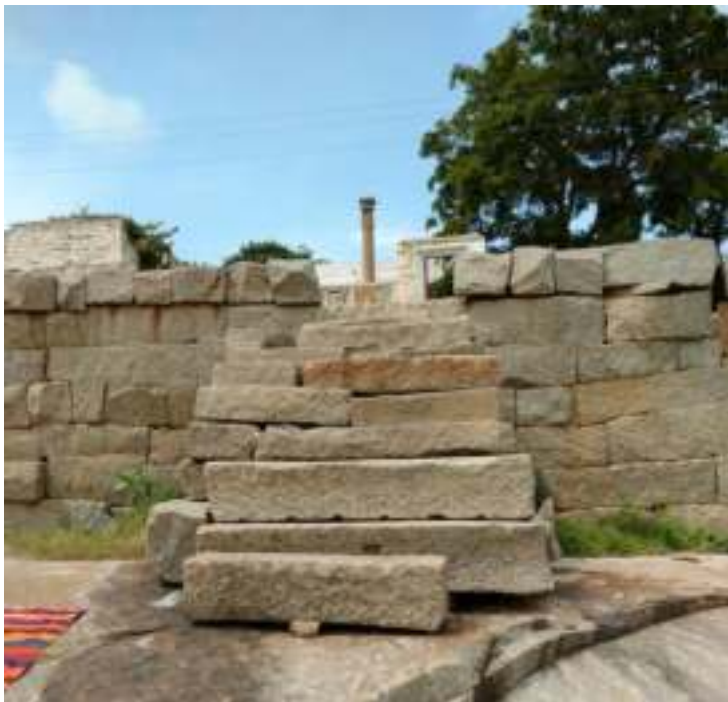
Comments: Ancient stones to be reused. The steps need to be restored to allow easy accessibility.

Figure 11: Steps of the fort wall need to be restored.

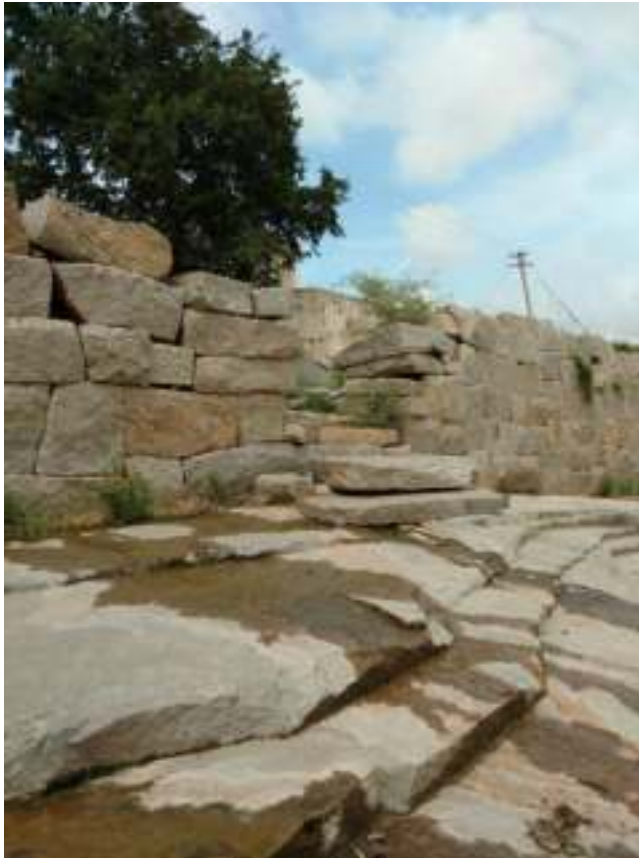
Figure 12: Steps need to be reinstalled.

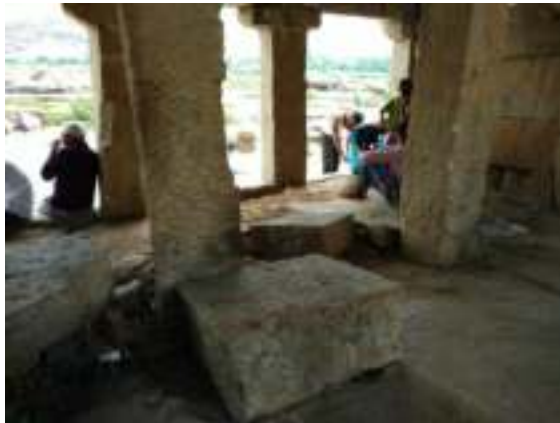
1. The Snanaghatta area with its Mantapas is frequently used by the locals. This “living” heritage is part of the identity of its people. Therefore, it is necessary to allow for the continuous use of the historic structures by the locals.

Figure 13: Locals use the 1st Mantapa at Snanaghatta regularly.

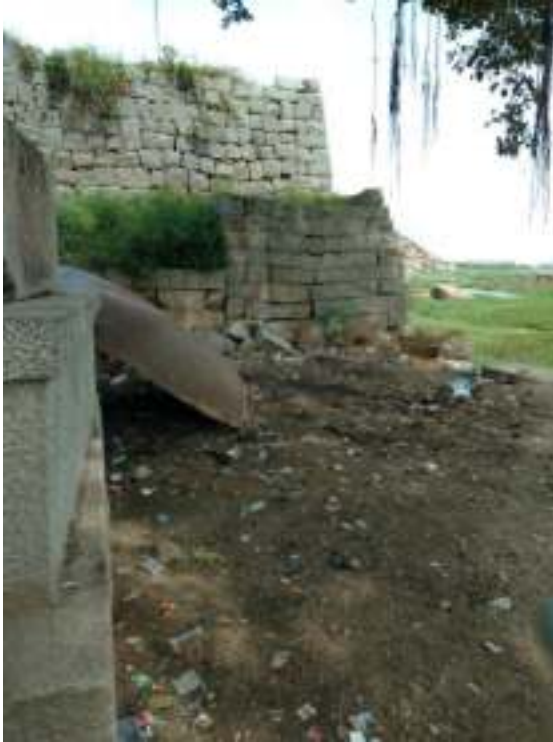
2. The Snanaghatta area needs to be cleared of all rubbish and debris.

Figure 14: At the Snanaghatta area - garbage needs to be cleared, the earth should be levelled.

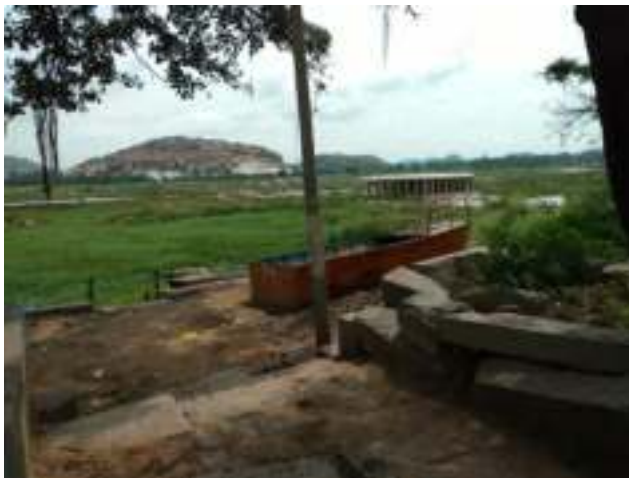
Figure 15: The river front - should be cleared of debris and garbage.

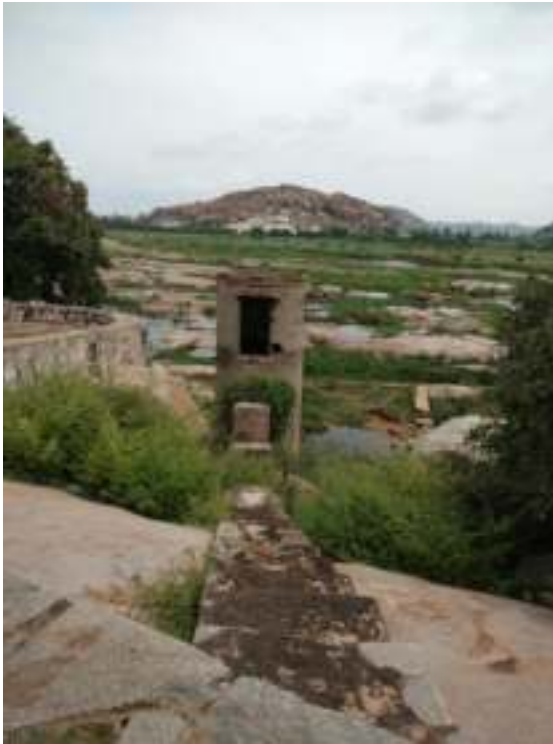
3. Additional lighting will help in maintaining the spaces.
4. The water tank which is not in use and the concrete steps to be removed as it is detrimental to the historic setting.

Figure 16: Water tank and steps to be removed.

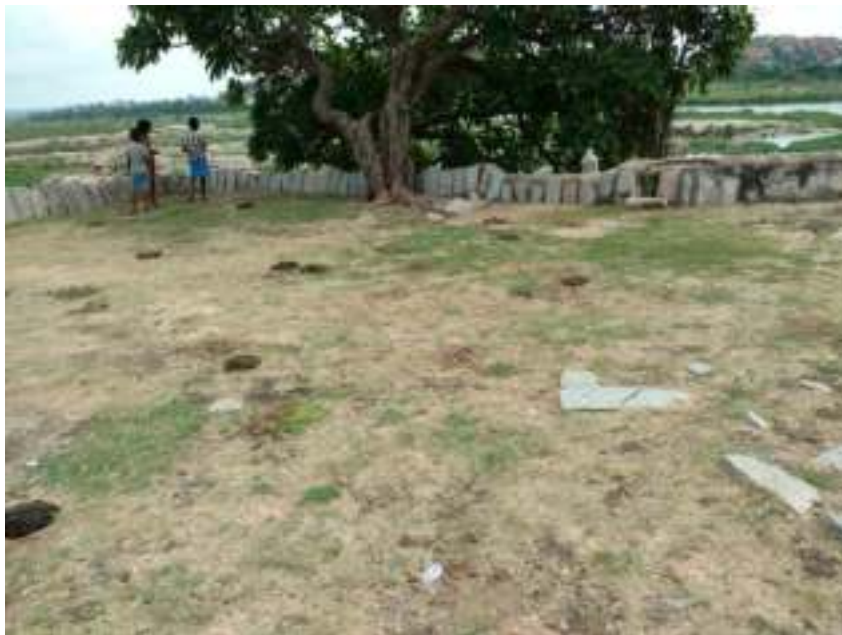
5. The outside courtyard at the entrance of the temple and the approach to temple should be levelled with compacted earth. PCC should be avoided as it is detrimental to the landscape setting.

Figure 17: Courtyard at the entrance of the main temple should be levelled with compacted earth.

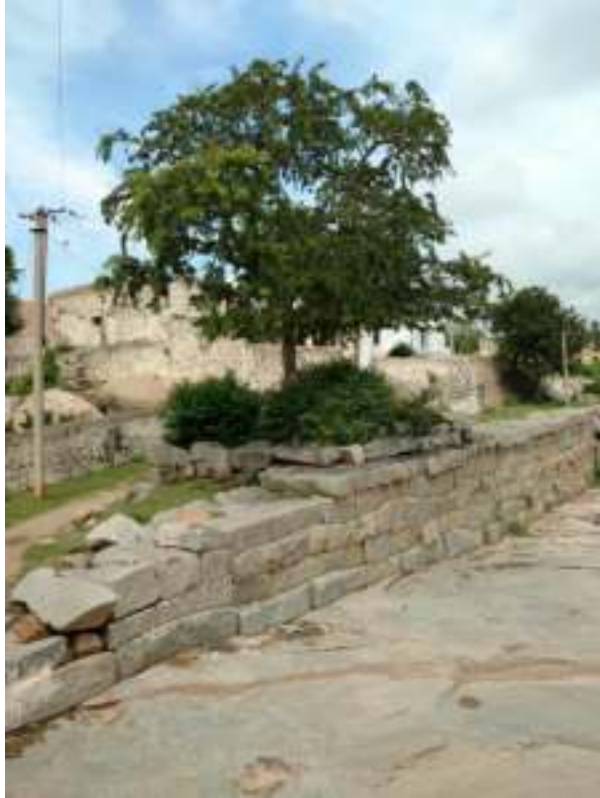
Figure 18: Approach to be levelled with compacted earth.
