Report by INTACH Anegundi Hampi Chapter

CONDITION ASSESSMENT OF SHRINE STREET

SHRINE STREET

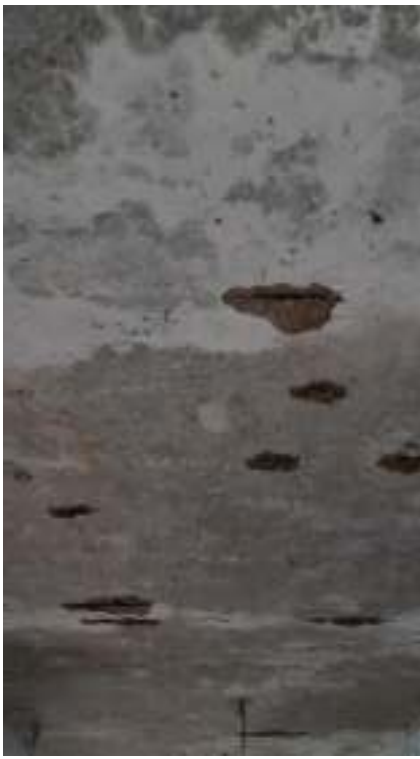
CORROSION OF RC SLAB

Use of poor quality concrete for slab construction and penetrating dampness has resulted in the corrosion of roof slab.

The concrete slab shall be replaced with a traditional stone slab construction that would be sympathetic to the shrine.

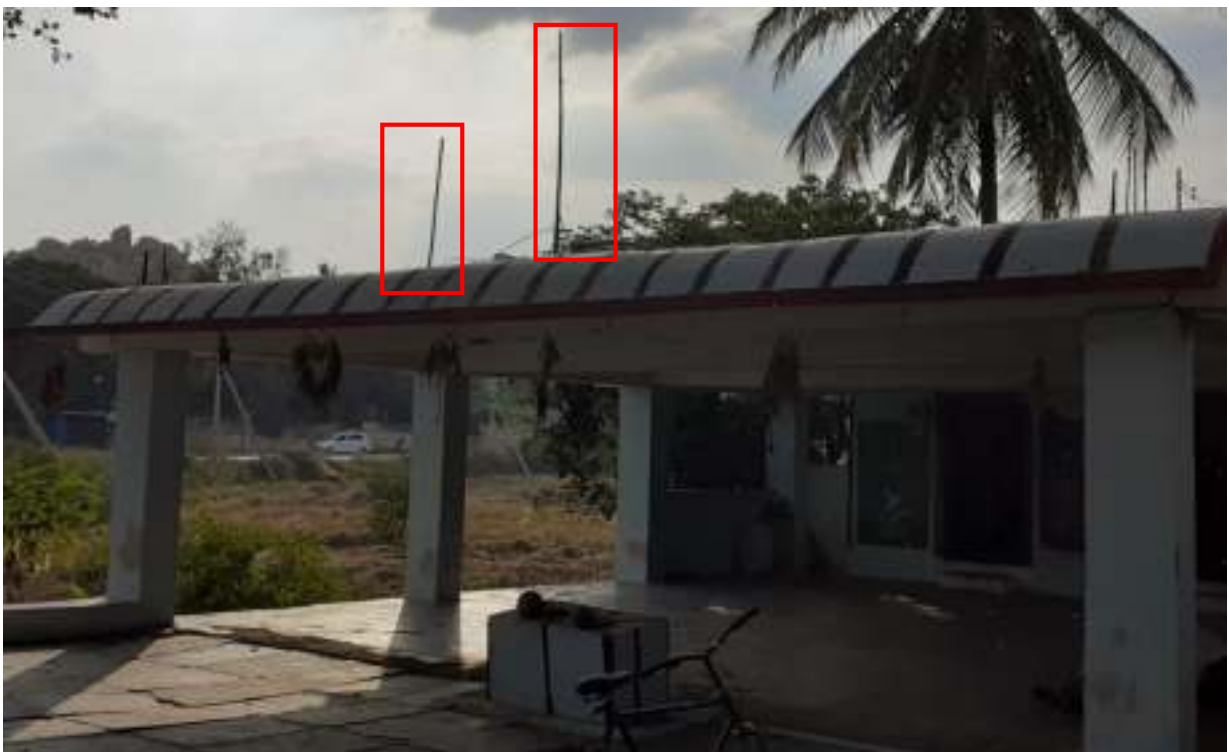
Steel bars projecting from the slab haphazardly that's been ignored since its construction.

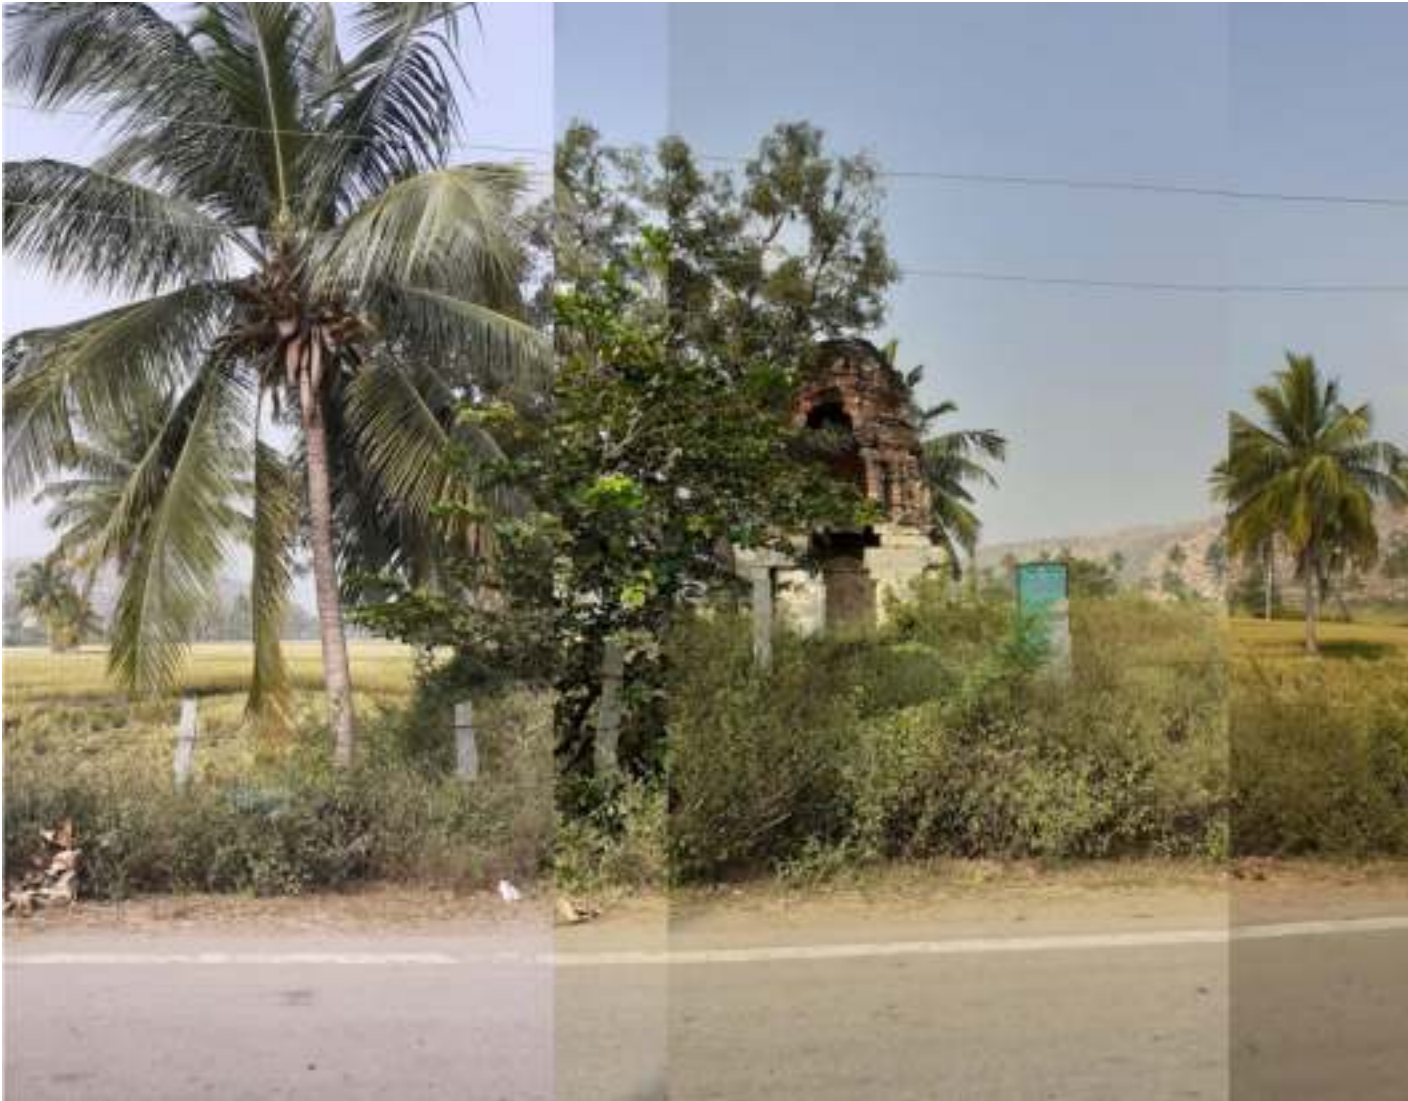
SHRINE 2

This Shrine located to the left of Honna Agasi in the middle of fields is devoid of access and lacks maintenance.

Pathway to be created to making it accessible for visitors and the shrine needs to be core cleaned by removing the paint layers.

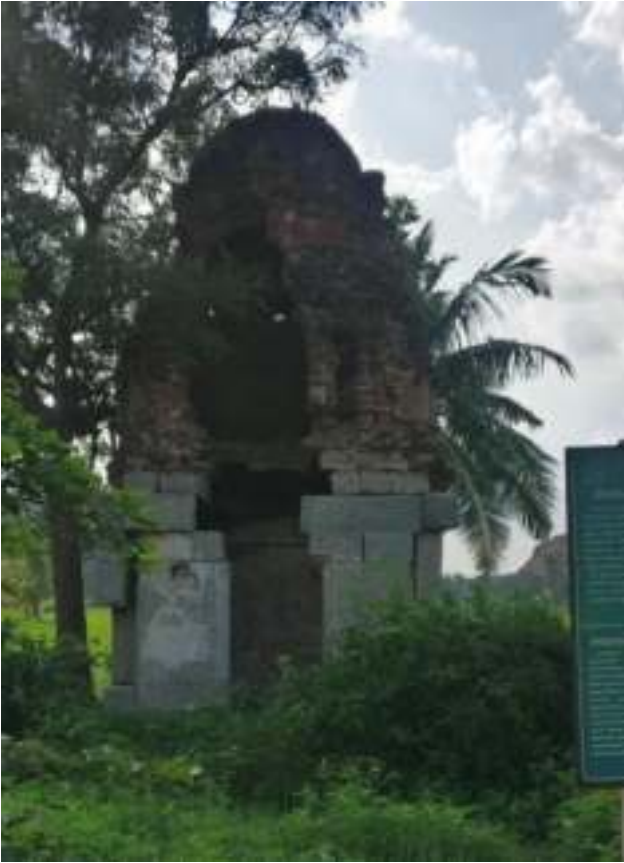
DILAPIDATED GOPURA

The brick Gopura is in a much dilapidated state leading to the growth of Vegetation, that damages the stability of Shrine. Though a part of the structure has got destructed, major portion of them are in a state that can be restored. Thereby, reconstructing the just the missing portion. Care should be taken to clear the vegetation and plaster the brick structure with a damp-proof coat.

The stone structure should be checked for structural stability and minimally intervened to make them stable.

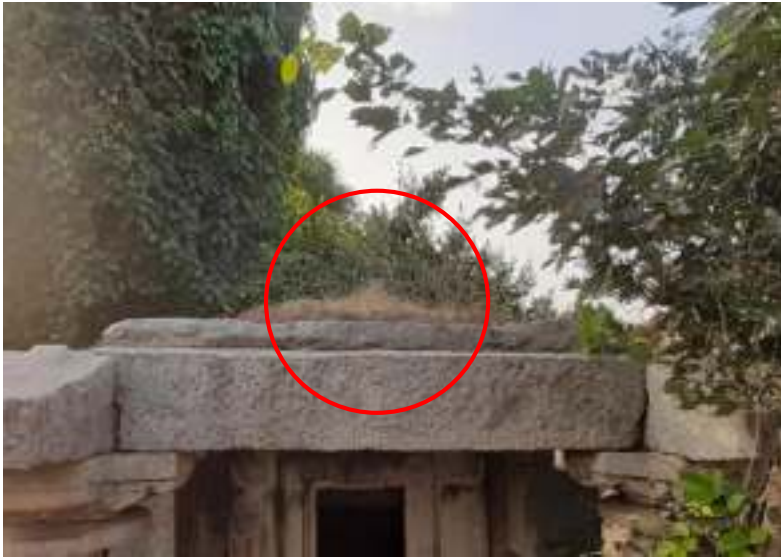
ROOF :

The stone masonry on the roof is in a much dilapidated state leading to the growth of Vegetation.

Care must be taken to remove the Vegetation and restore the roof structure, covering it with a damp-proof coat.

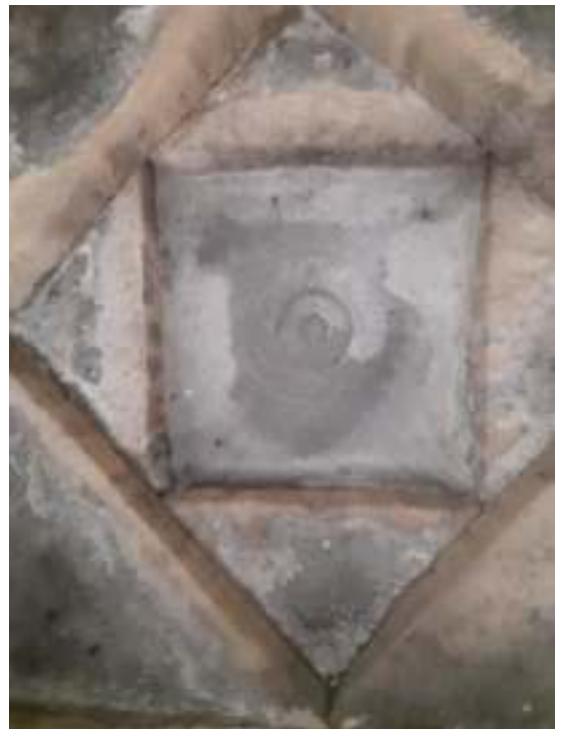
RETAINING DAMPNESS

The ceiling of the shrine is deteriorated due to the penetration of dampness from roof, that has led to salt deposition.

Measures to be taken for the removal of dampness and salt deposit as well as arresting the source of dampness and applying a layer of damp-proof coat over the surface.

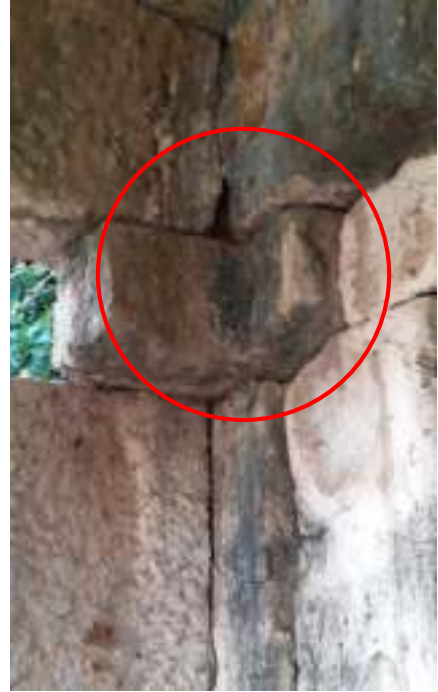
WALLS : ALGAL STAINS

Dampness retaining on the wall surface and lack of maintenance has led to the formation of moss over it. Core cleaning of the walls suggested to remove the algal stains post which the surface would be coated with a damp-proof layer.

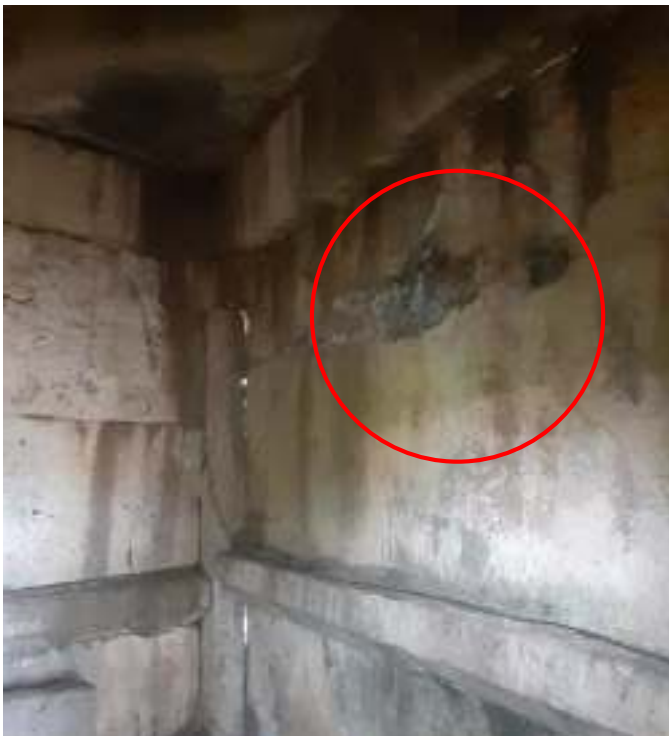
WEATHERING OF STONE

Weathering of stone surface in the interior walls due to poor air quality, that needs to be treated appropriately.

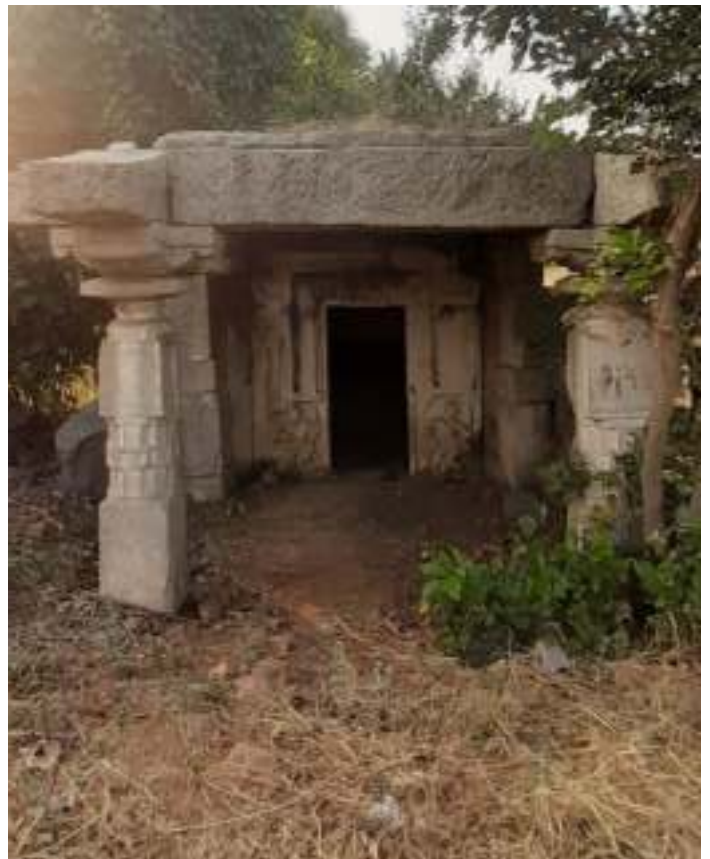
LEVELING THE SURFACE

Parts of the shrine has submerged under ground due to the constant raise in road level.

The vegetation and debris needs to be cleared and care should be taken to level make them accessible for the visitors.

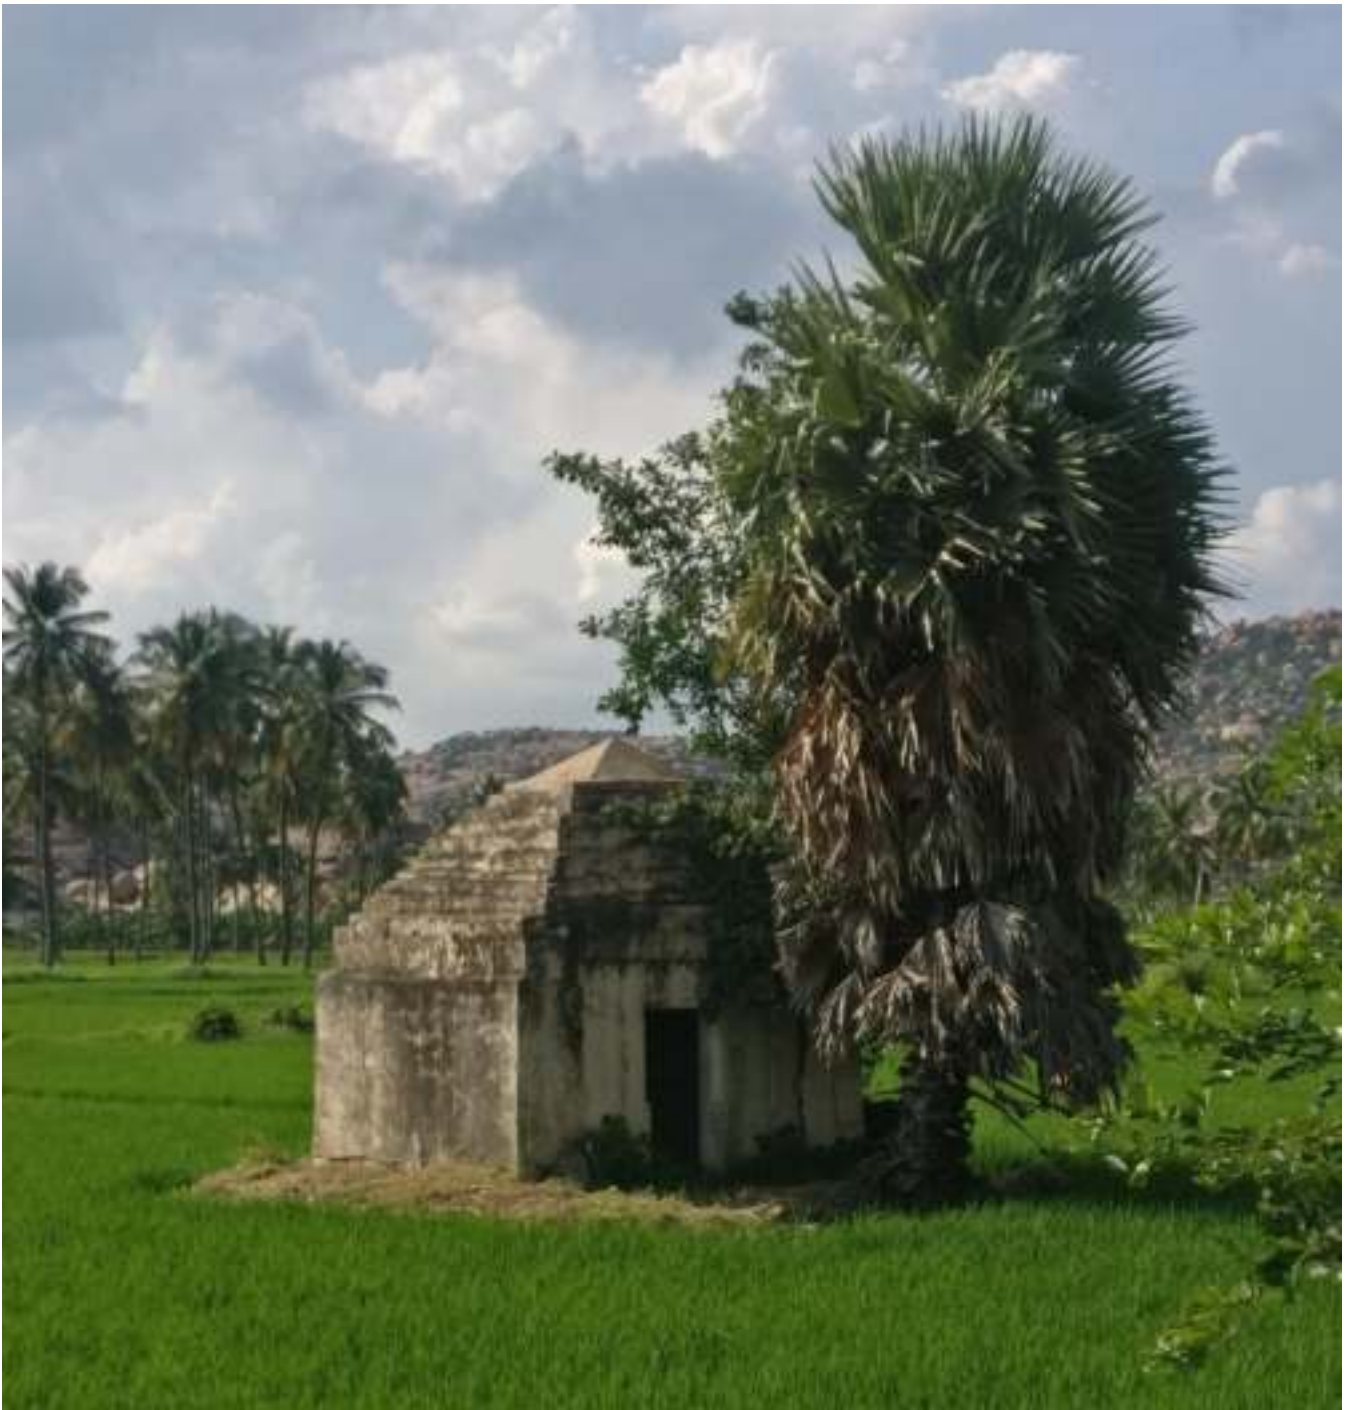
Shrine located at the rear side of Shrine 3- is devoid of access and lacks maintenance.

Pathway to be created to making it accessible for visitors and the shrine needs to be core cleaned by removing the paint layers.

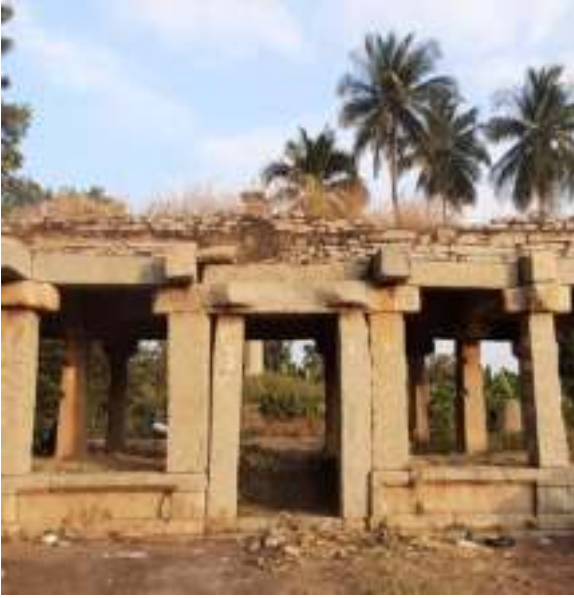
ROOF :

The stone masonry on the roof is in a much dilapidated state leading to the growth of Vegetation.

Care must be taken to remove the Vegetation and restore the roof structure, covering it with a damp-proof coat.

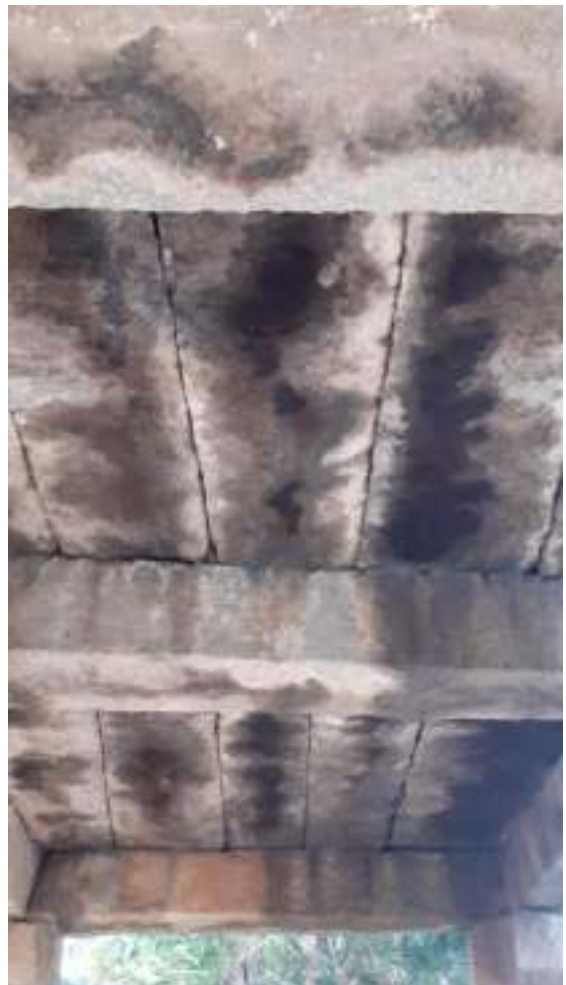
CEILING : **RETAINING DAMPNESS**

The ceiling of the Mandapa is deteriorated due to the penetration of dampness from roof, that has led to moss deposition.

Measures to be taken for treating the dampness and the moss deposit as well as arresting the source of dampness by applying a layer of damp-proof coat over the surface.

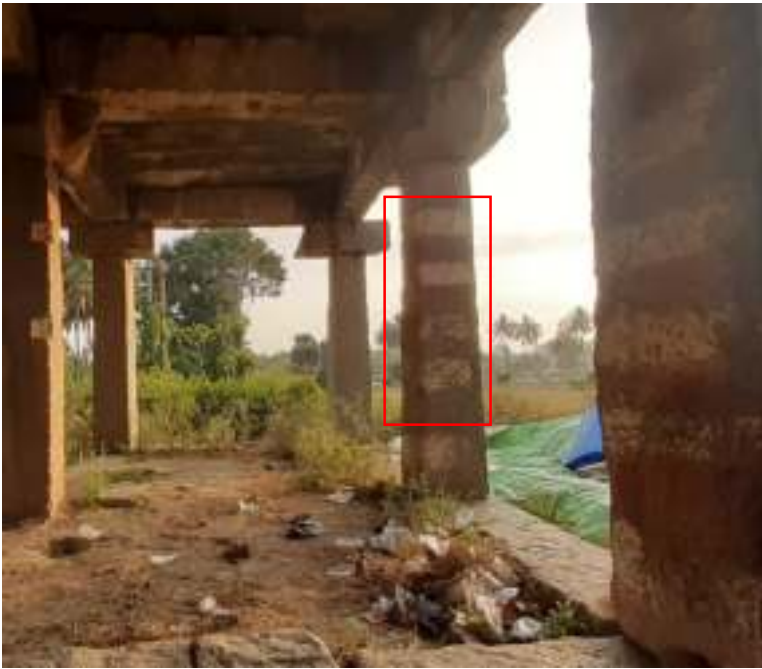
REMOVAL OF PAINT

Pillars painted with white enamel bands to be removed as they degrade the integrity of the structure.

Accumulation of trash and vegetation grown all over the platform need to be cleared.

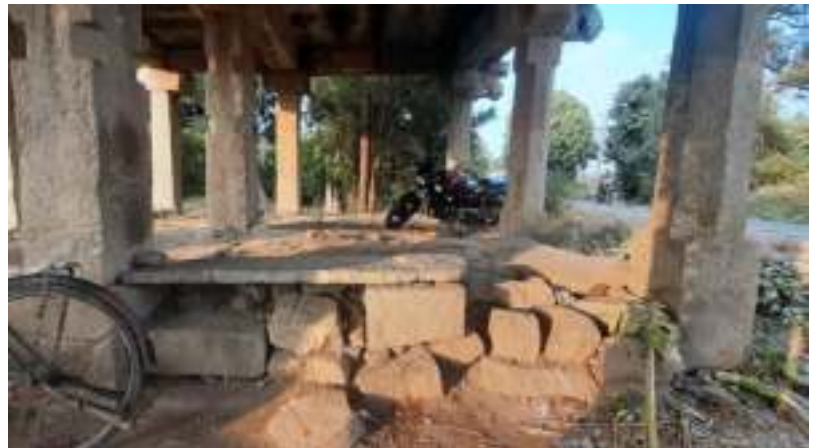
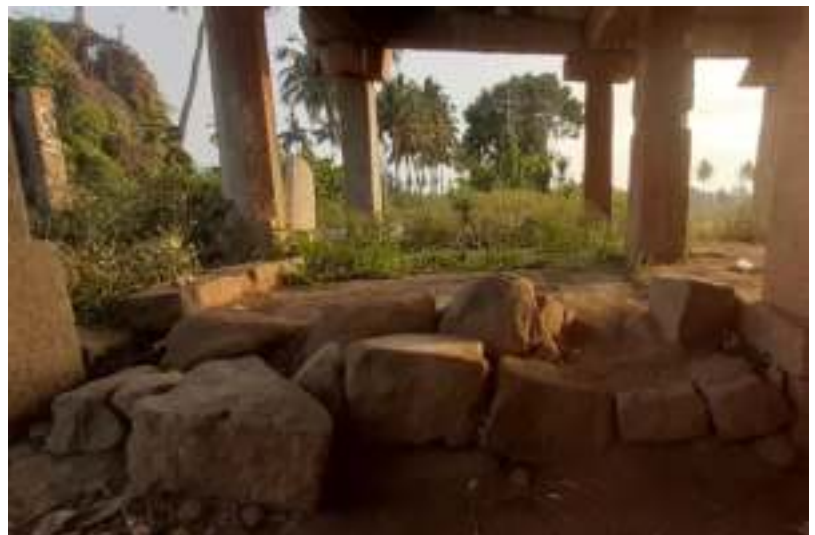
RECONSTRUCTING THE PLATFORM

The platforms on either side is in a much dilapidated state. Stone block lying haphazardly, accumulation of debris and vegetation grown all over deteriorate the architectural and aesthetic significance of the structure.

The vegetation and debris needs to be cleared and the platform needs to be leveled and reconstructed.

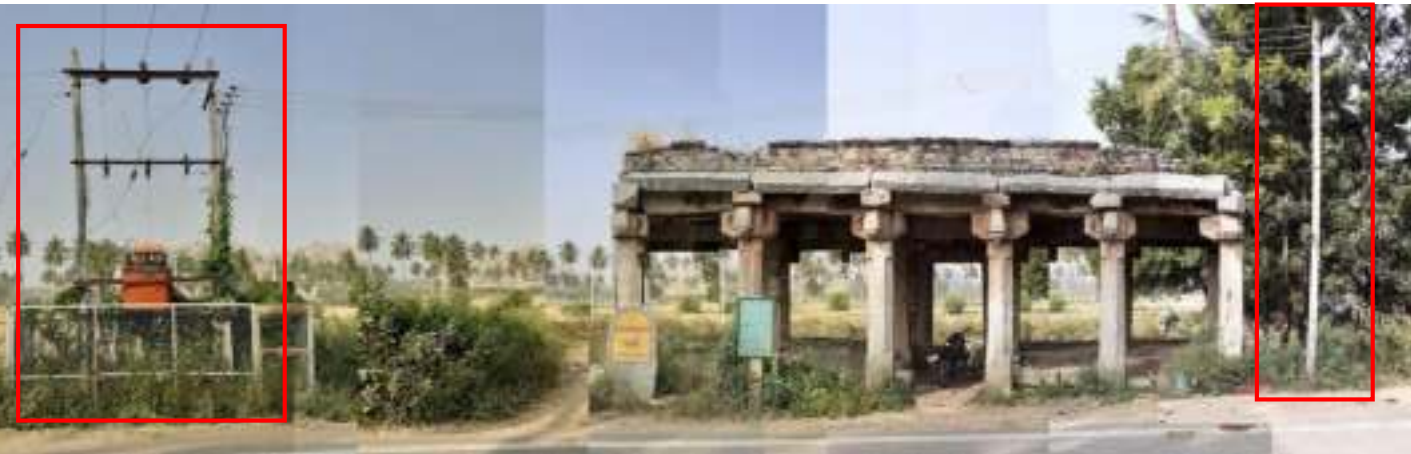
Location of the electric posts and transformers acts as a visual barrier across the shrine stretch and is proposed to have an underground electrical line instead of the existing one.

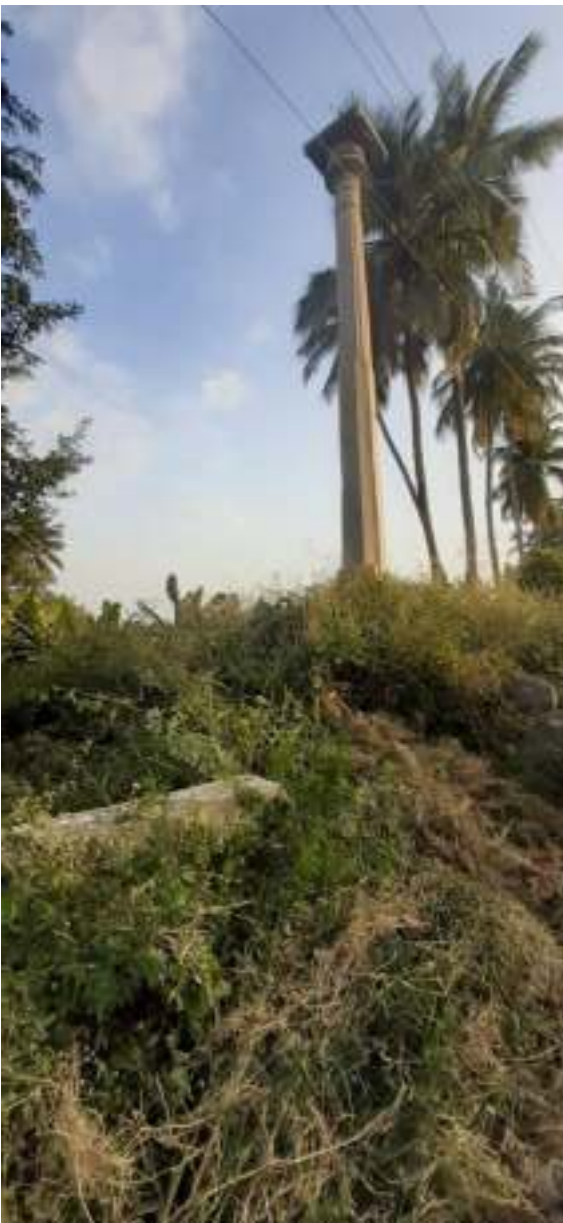
RESTORING THE PLATFORM

The Stamba has been restored and is devoid of any structural issues. But the platform over which the Stamba stands is in a dilapidated state and is covered with vegetal growth.

Care should be taken to clear all the vegetation and restore the platform.

Bushes around the platform also needs to be cleared with an appropriate landscape designed to signify the monument.

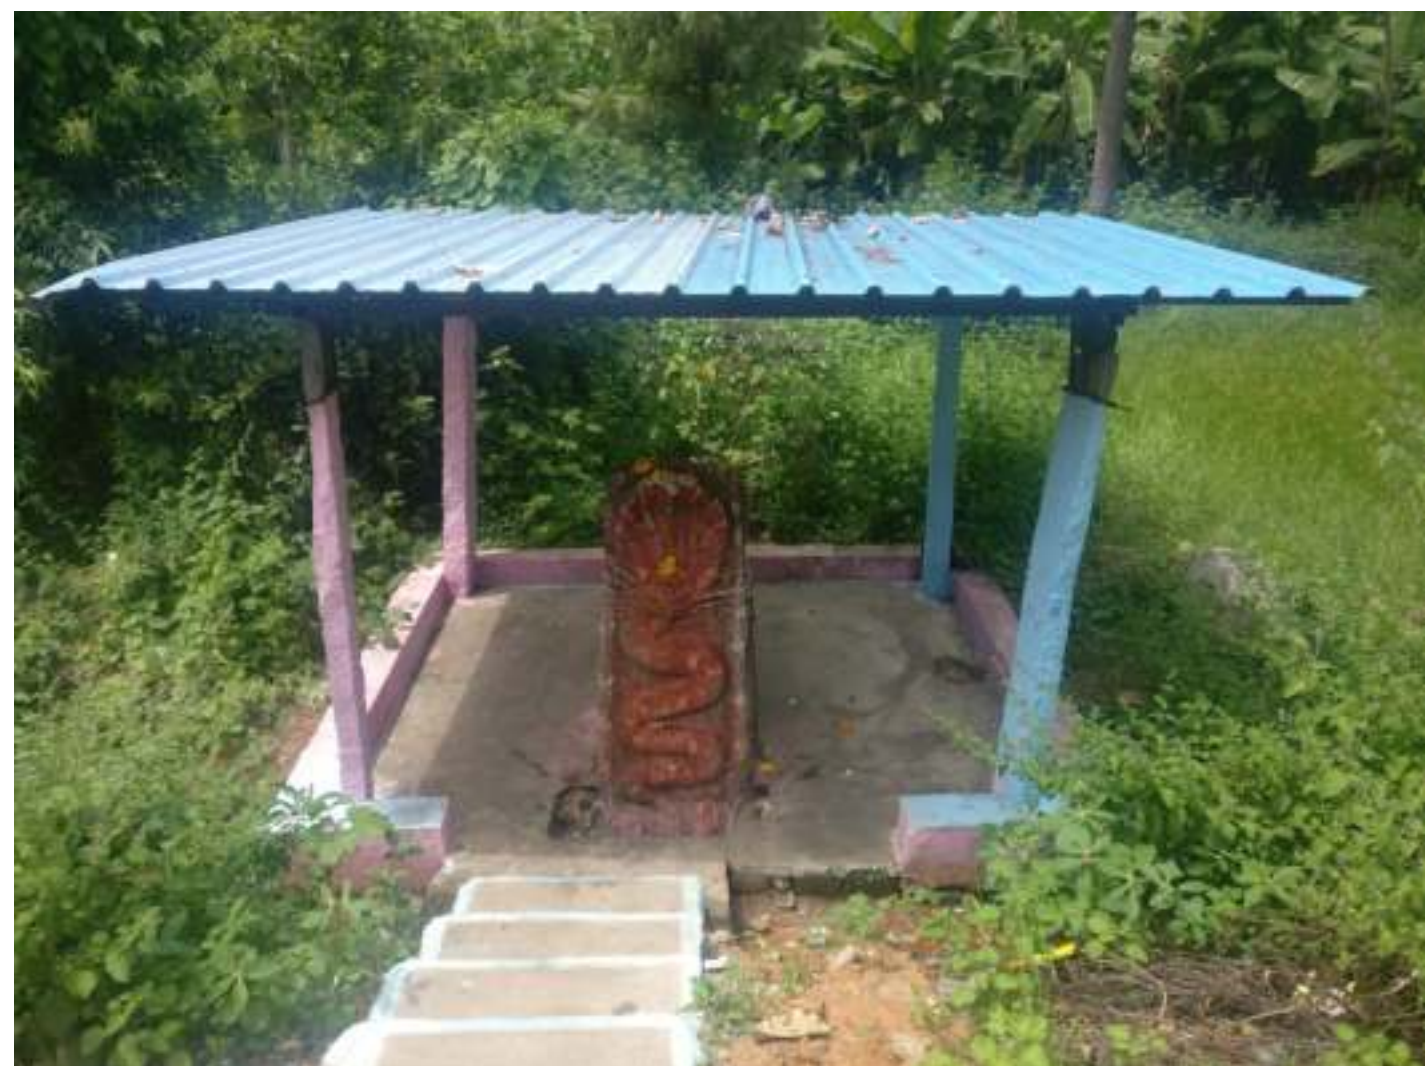
The structure over the Naga shrine has been constructed lately and the roof is unsympathetic to context. The asbestos sheet shall be replaced with an appropriate material that looks harmonious.

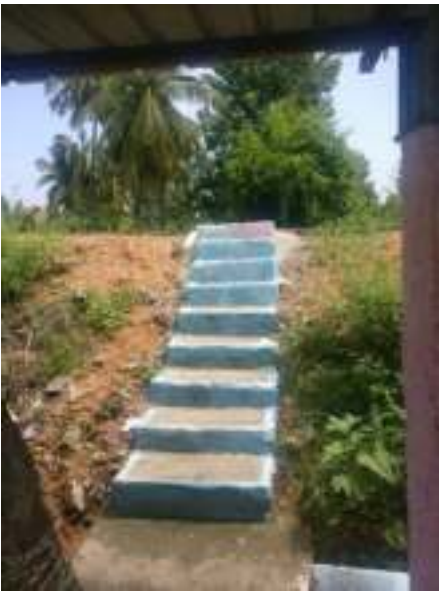
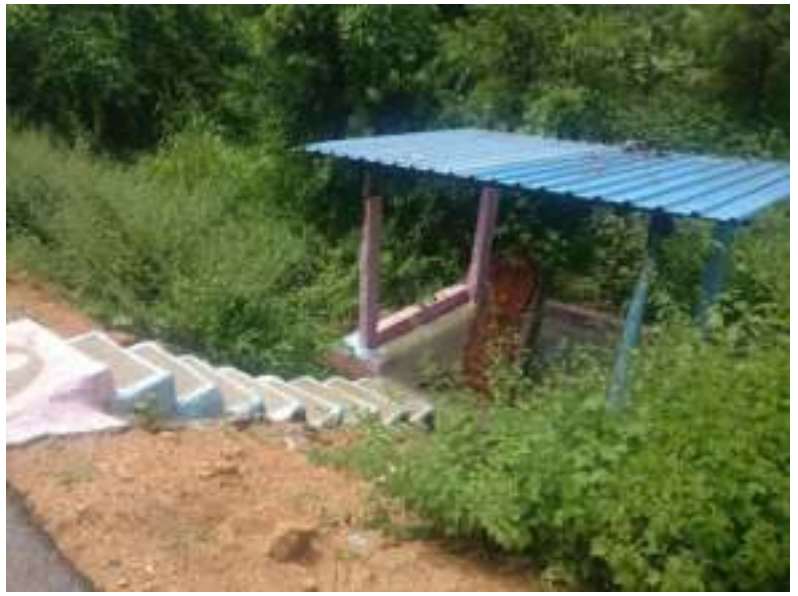
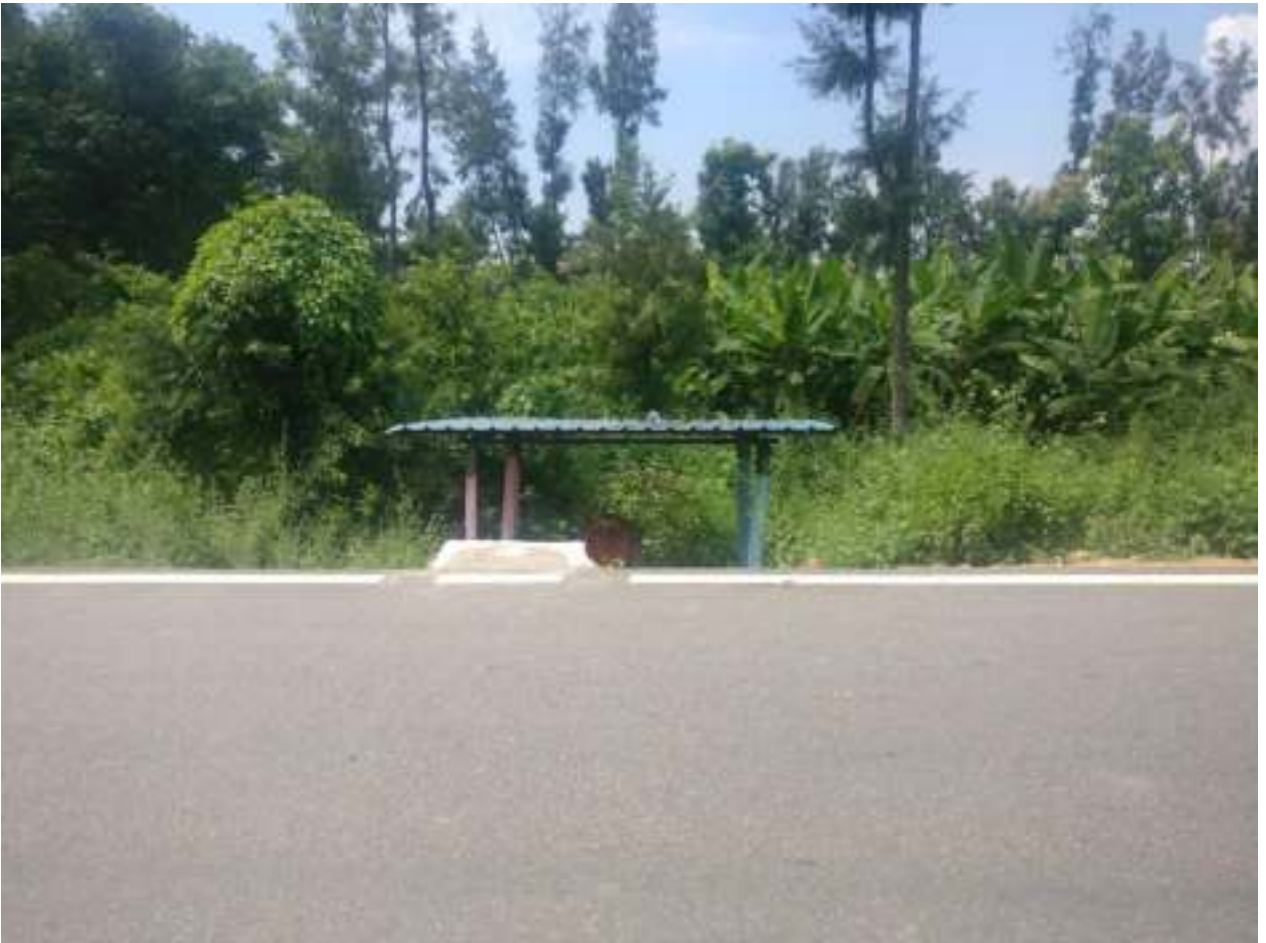
Due to the raise in road level, greater part of the shrine has gone underground that makes it hardly visible in the first site. Interventions shall be done in a way that it shall be made easily noticeable is surrounded by an appropriate landscape design.

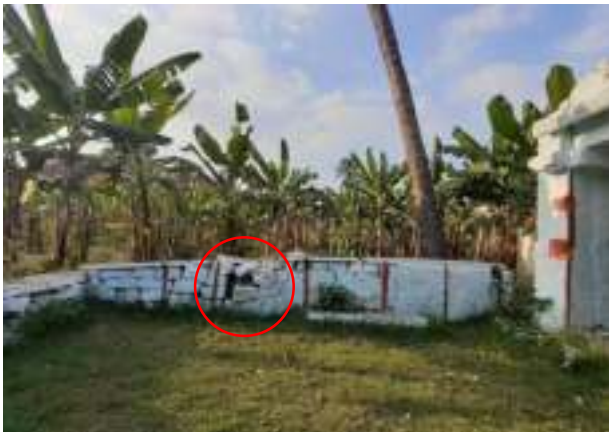
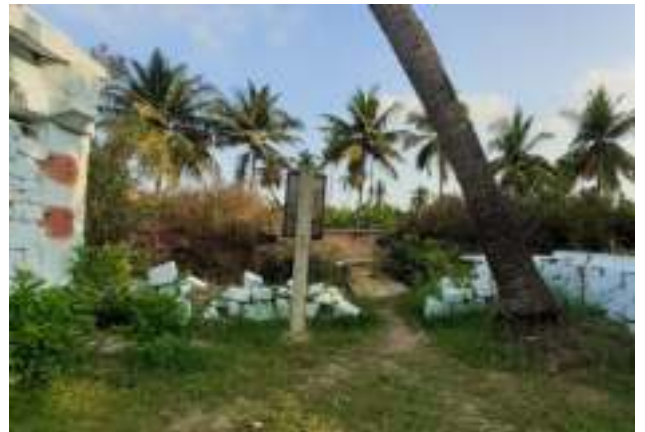
RESTORING THE BOUNDARY WALLS

The boundary walls are damaged to a certain extent and needs to be minimally restored.

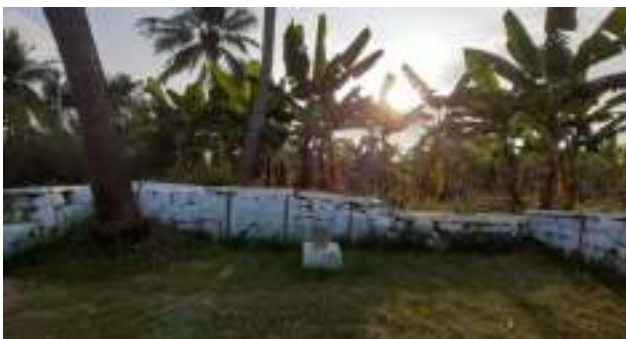
Clearing the unwanted vegetation to be done, while designing an appropriate landscape using indigenous plant species at the shrine entrance.

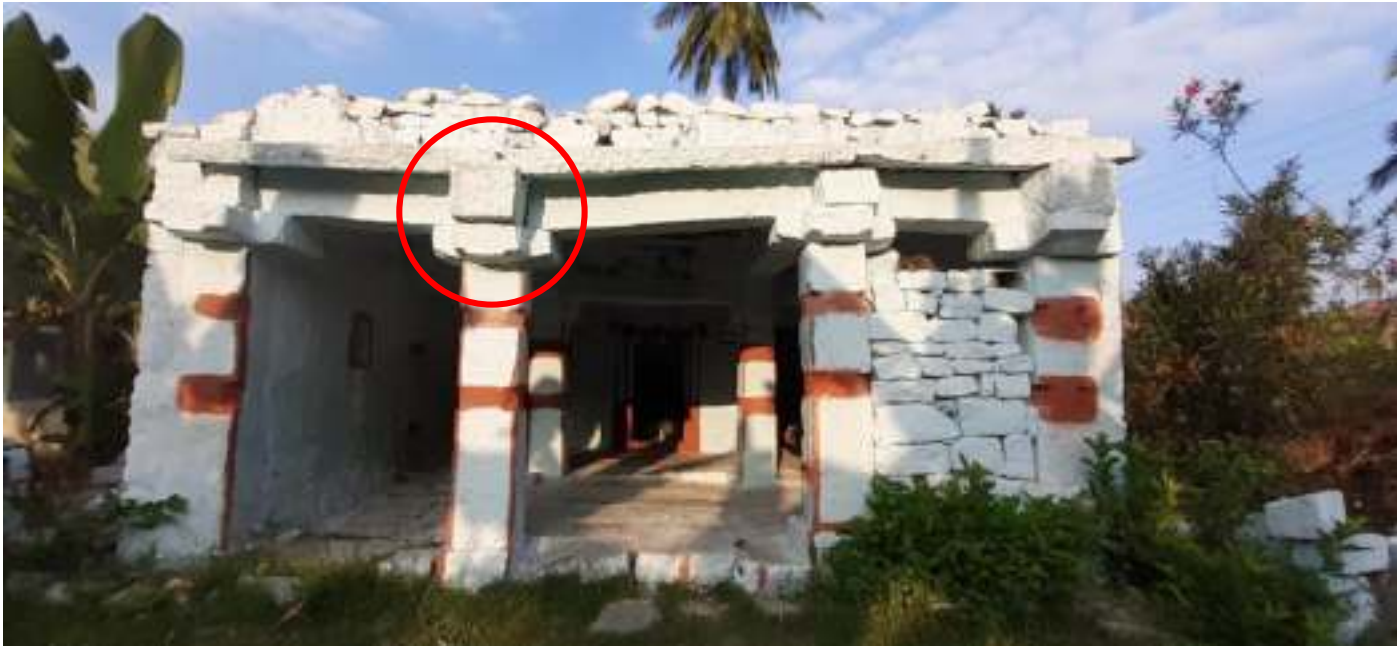
DISLOCATION OF BEAMS

The settlement of column has led to the dislocation of beams on either side resulting in structural instability.

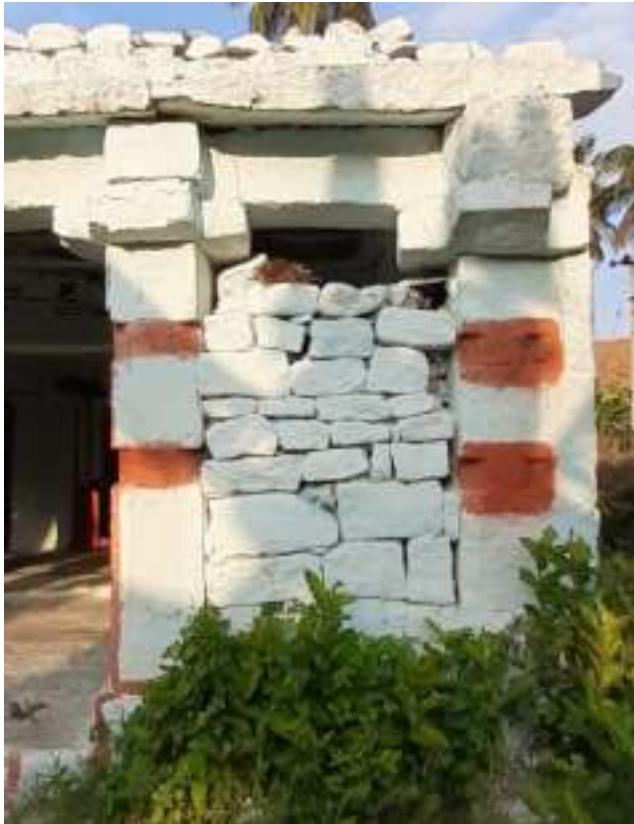
Spaces between the columns has been filled using stone masonry lately -that needs to be removed as it deteriorates the aesthetic significance of the shrine.

Application of inappropriate paints of different colors all over the stone structure has degraded its integrity and has to be thoroughly removed.

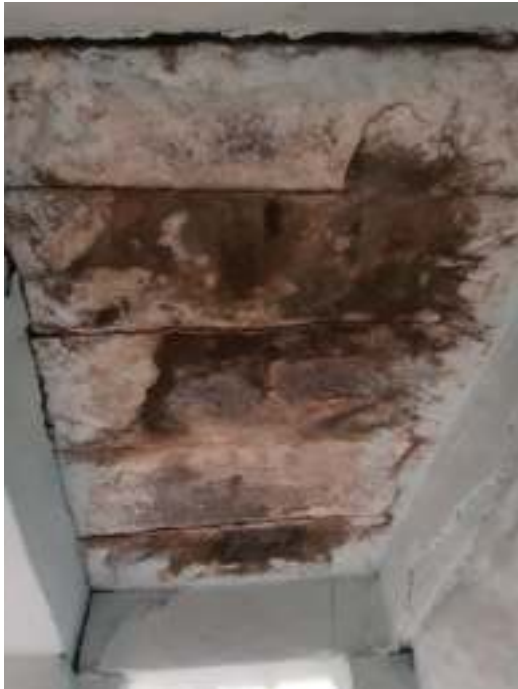
PENETRATING DAMPNESS

Patches indicating dampness is witnessed all over the ceiling that has penetrated from the roof.

This has also led to weathering of the stone surface.

Measures should be taken to treat the stone slabs and arrest the source of dampness.

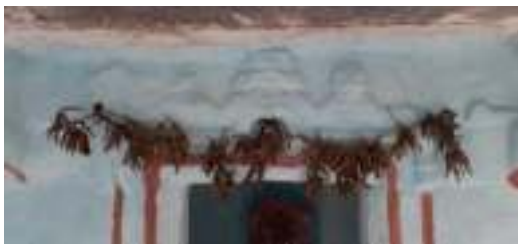
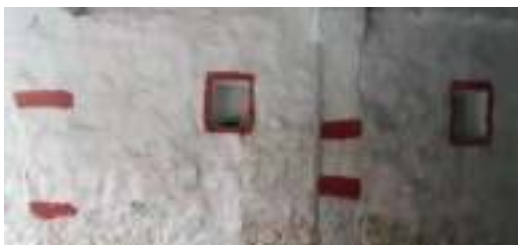
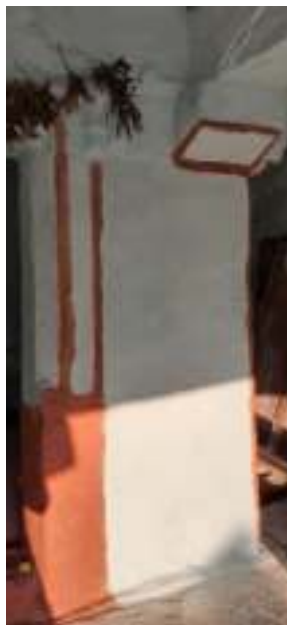
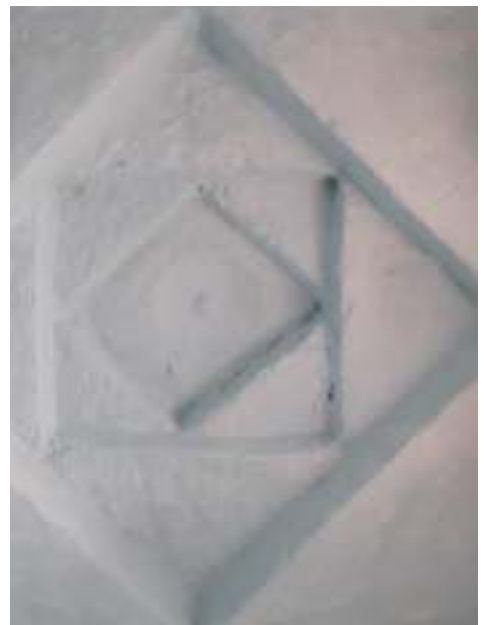
REMOVAL OF PAINT

Several coats of paint applied over the sculptures, columns and ceiling of the shrine degrade the historical and architectural value of it and needs to be removed.

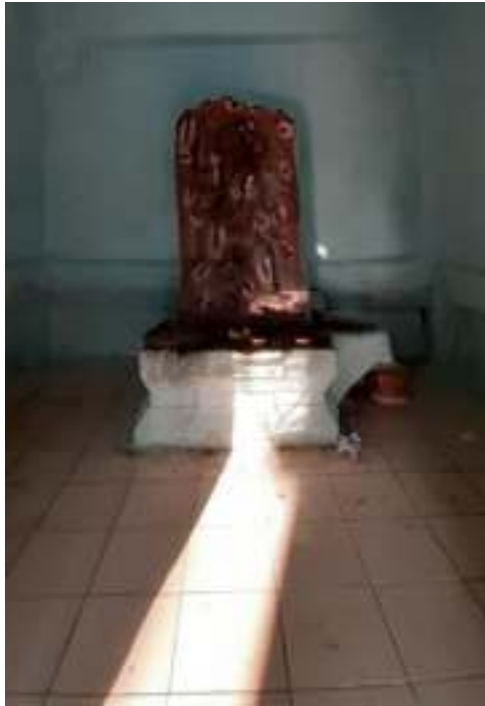
REMOVING THE TILE FLOORING

Tiles added to the floors of Sanctum needs to be removed and replaced with authentic stone flooring.

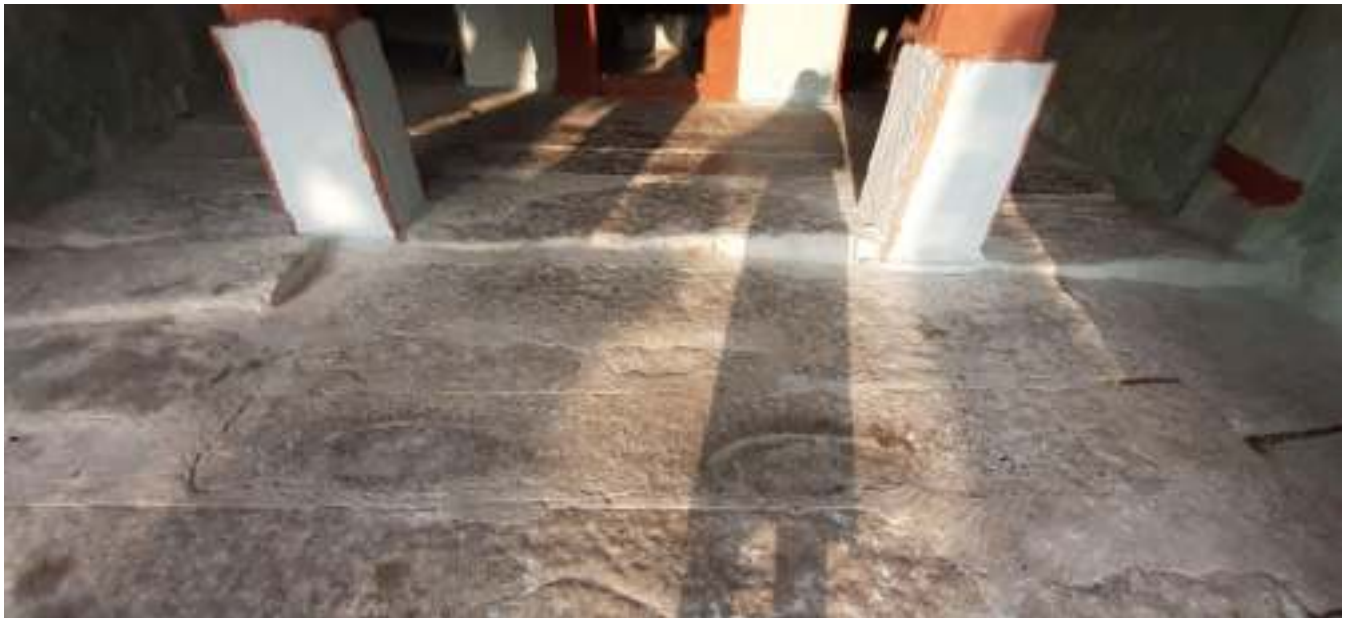
Flooring outside the sanctum remains intact and does not need any interventions to be done.

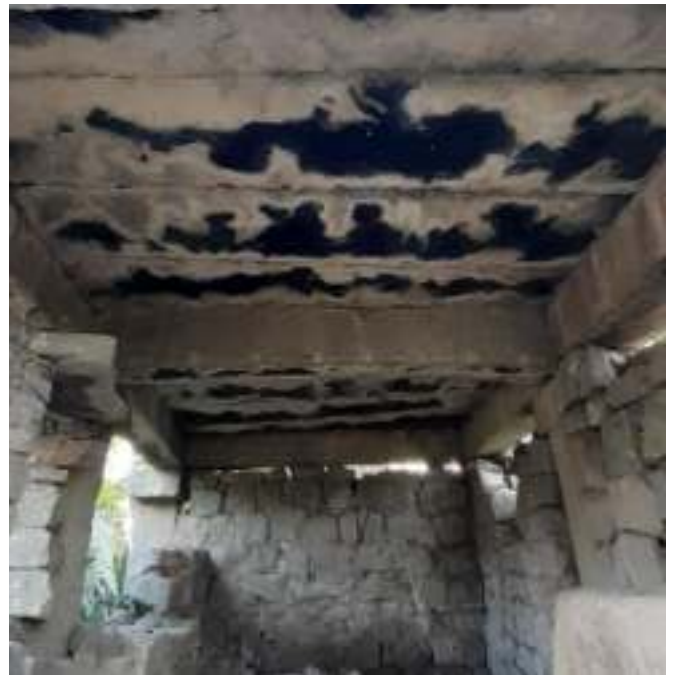
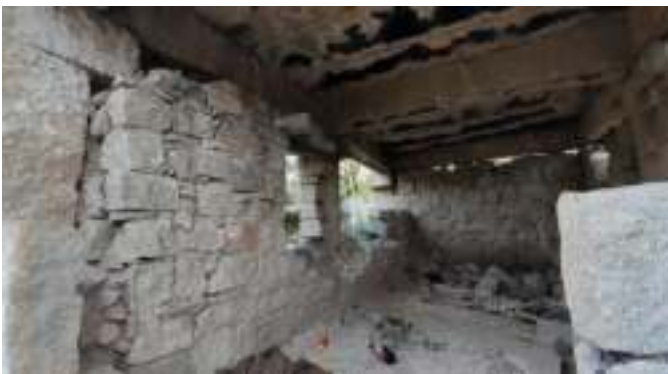
CEILING

Spaces between the columns has been filled using stone masonry lately -that needs to be removed as it deteriorates the aesthetic significance of the shrine.

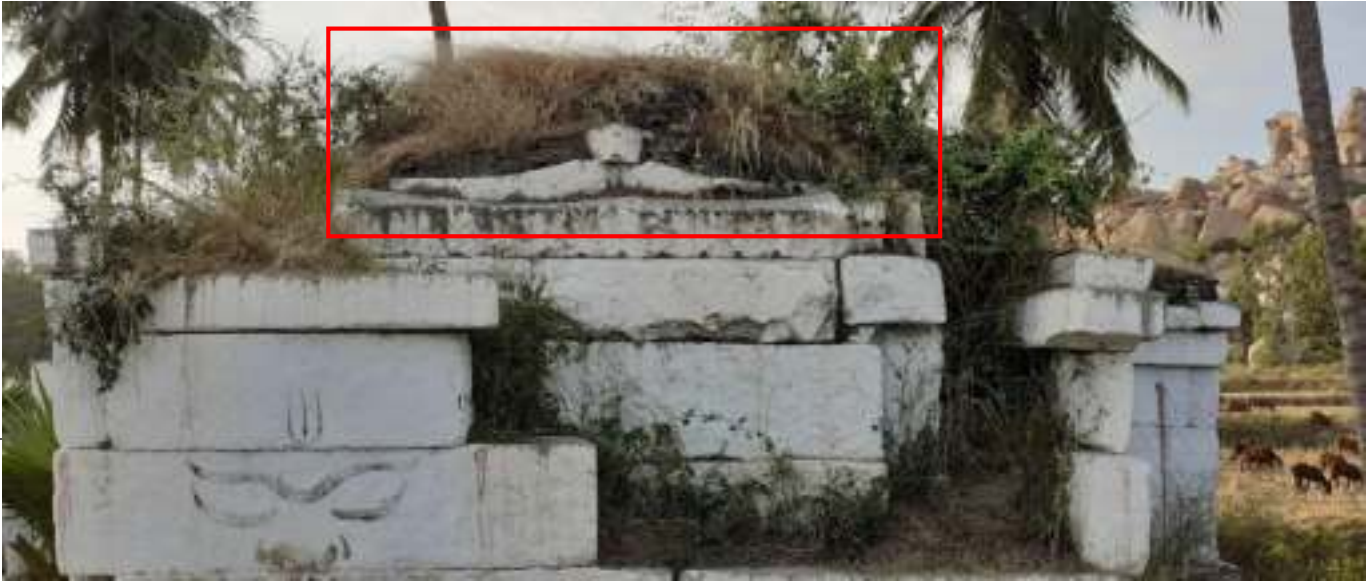
ROOF

The Gopura, constructed of brick is in a much dilapidated state leading to the growth of Vegetation, that subsequently damages the stability of Shrine.

The vegetation shall be removed and Gopura shall be restored using appropriate materials.

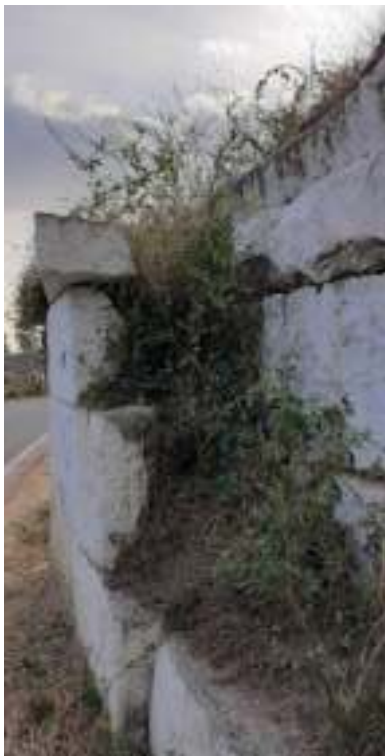
VEGETATION GROWTH

Damaged exterior walls giving way to vegetation growth, that can extensively damage the structural stability of the shrine.
