Report by INTACH Anegundi Hampi Chapter

CONDITION ASSESSMENT OF SHRINE STREET

SHRINE STREET

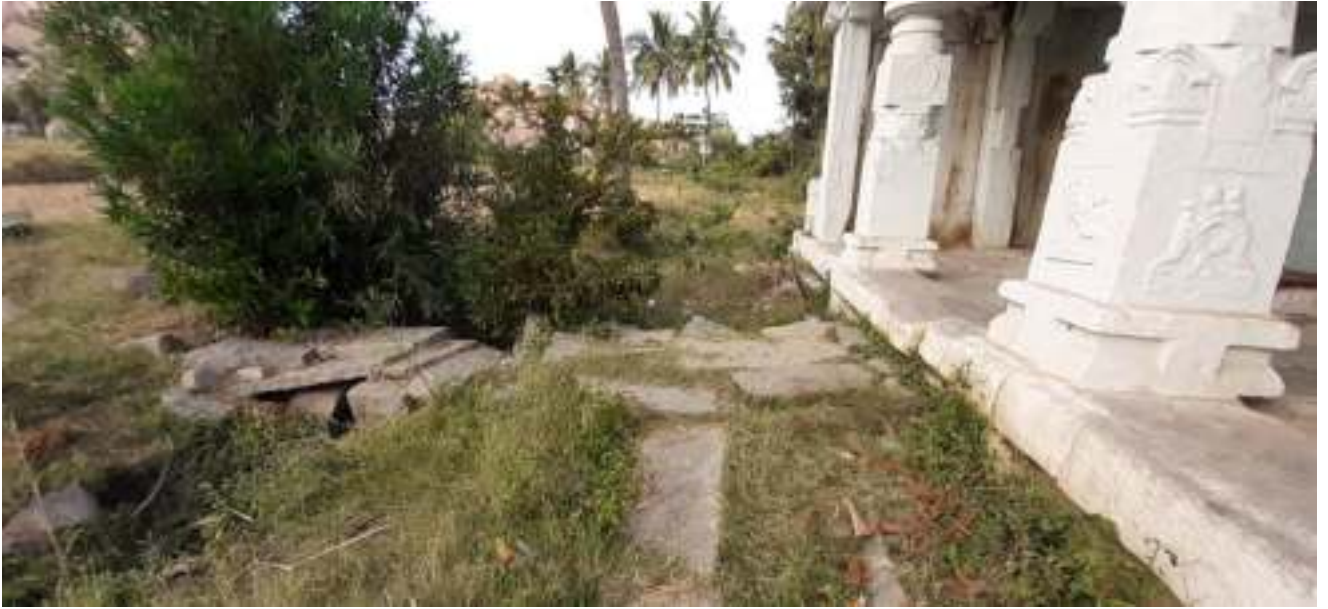
RESTORING THE PATHWAY

The pathway leading to the shrine lacks maintenance and needs to be re-designed to make it easily accessible for the visitors.

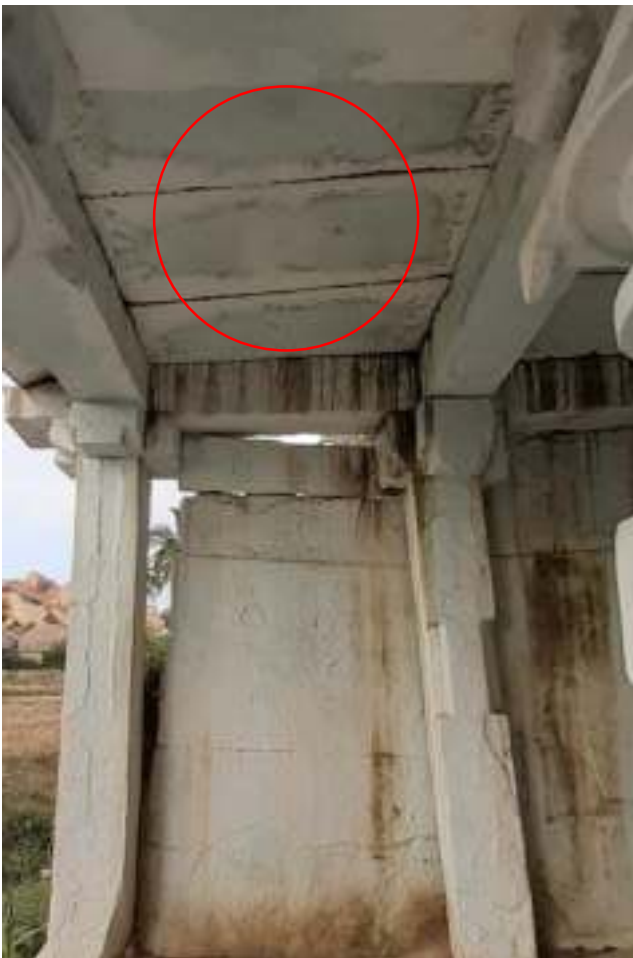
DAMPNESS

Patches indicating dampness penetrating from the roof shall be identified all along the stone slab.

Due to water leakage from the roof algal stains can be identified along the beams- that shall be removed by core cleaning of the surface.

The source of dampness needs to be identified and arrested.

Source of the leakage needs to be arrested.

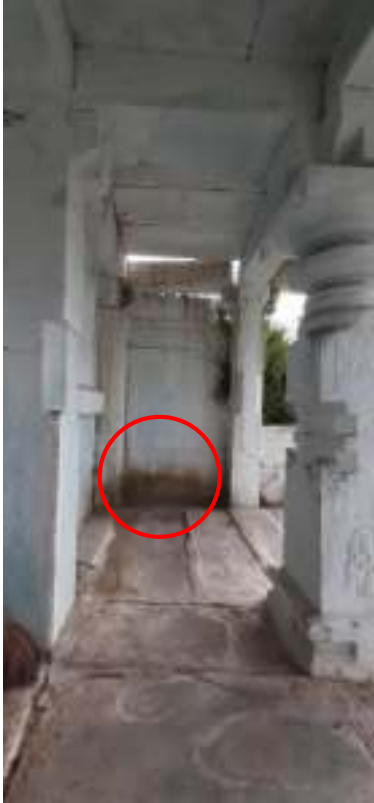
REMOVAL OF PAINT

Structure coated with inappropriate paints all over has degraded its integrity and has to be thoroughly removed.

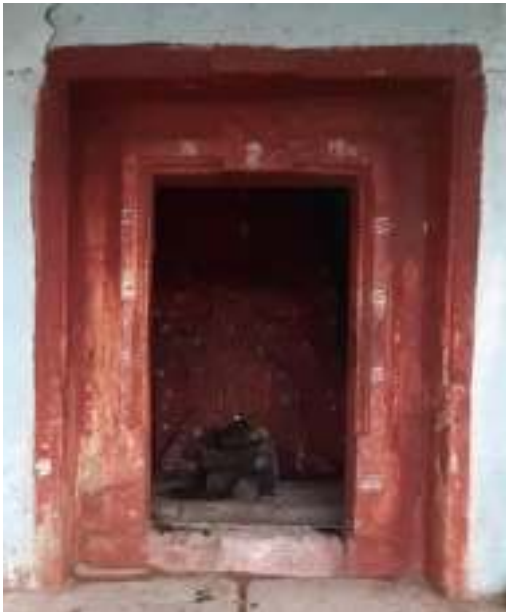
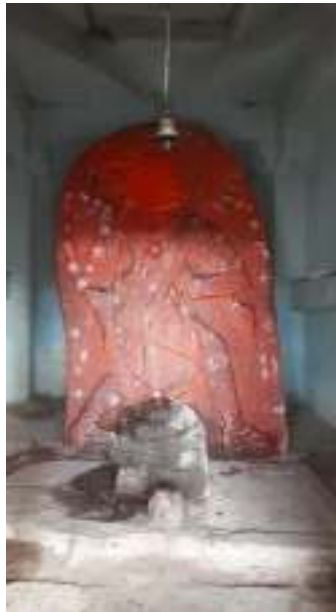
Sanctum gateway and main sculpture unsympathetically coated with enamel paints- degrading the integrity of the shrine and needs to be thoroughly removed.

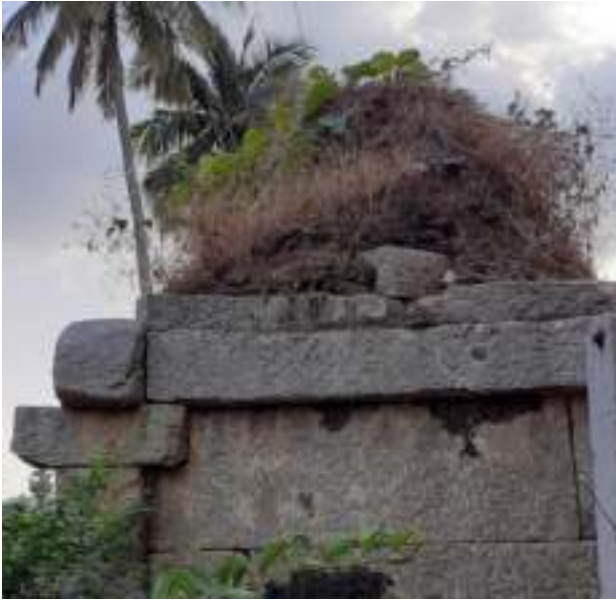
DILAPIDATED GOPURA

The Gopura, constructed of brick is in a much dilapidated state leading to the growth of Vegetation, that subsequently damages the stability of Shrine. The vegetation shall be removed and Gopura shall be restored using appropriate materials.

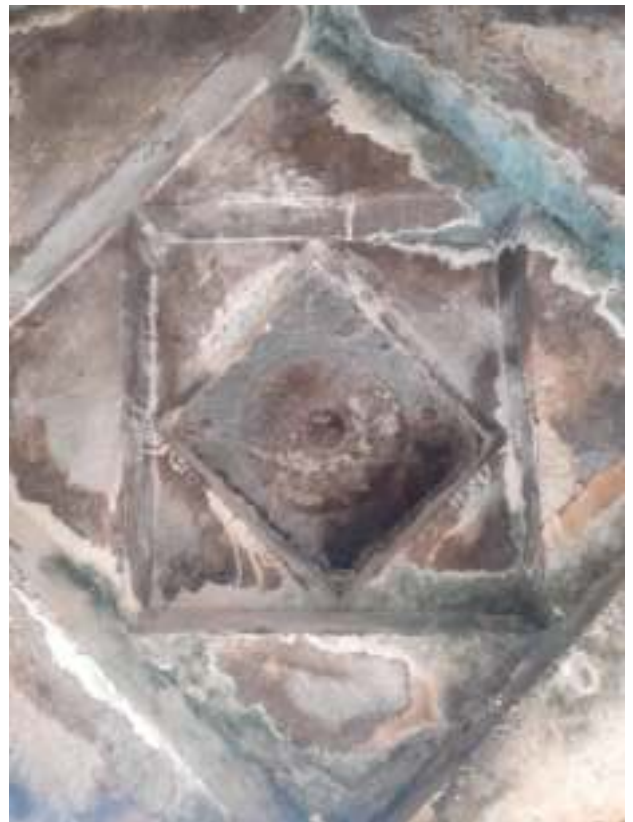
RETAINING DAMPNESS

The ceiling of the shrine is deteriorated due to the penetration of dampness from roof, that has led to salt deposition.

Measures to be taken for the removal of dampness and salt deposit as well as arresting the source of dampness and applying a layer of damp-proof coat over the surface.

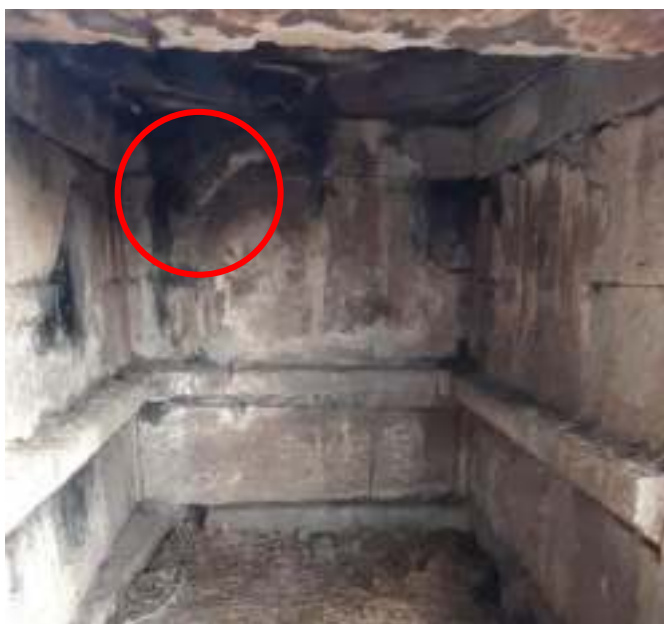
ALGAL DEPOSIT

Dampness retaining on the wall surface due to poor indoor air quality and lack of maintenance has led to the formation of moss over it.

Core cleaning of the walls suggested to remove the algal stains post which the surface would be coated with a damp-proof layer.

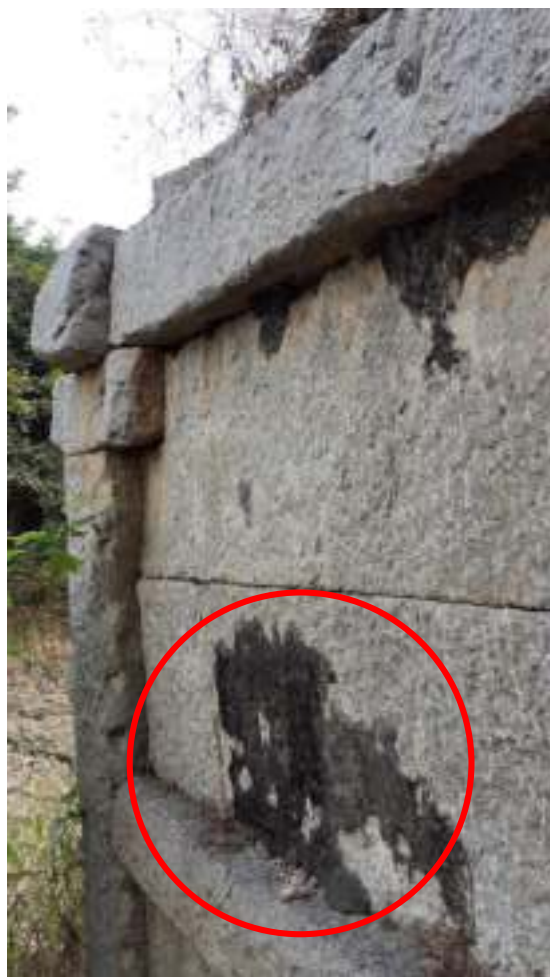
(Image on the left) Algal stains found on the exterior wall surfaces.

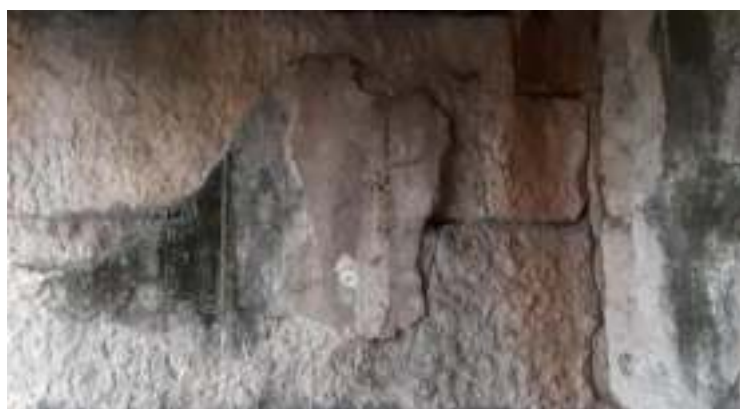
(Image above) Flaking of paint/plaster added to the stone surface lately that has been affected with algal stains.

Care to be taken to remove all the paint layers.

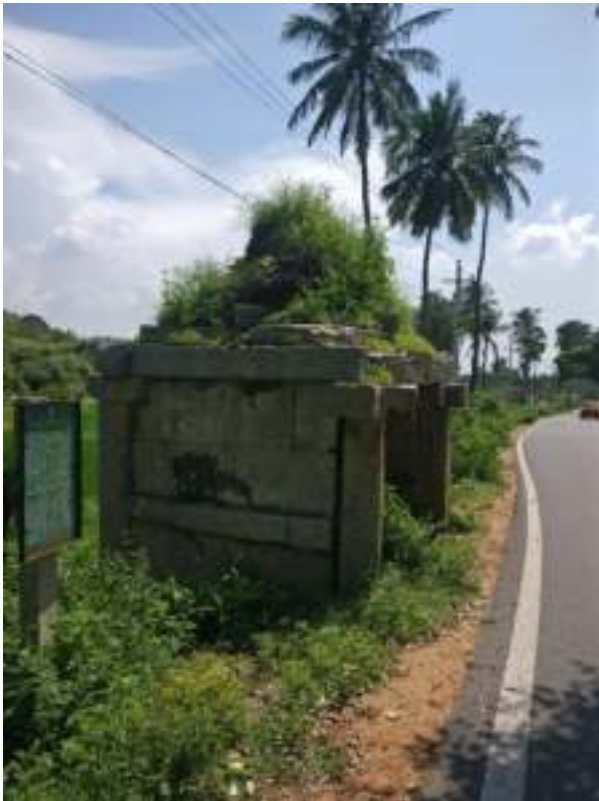
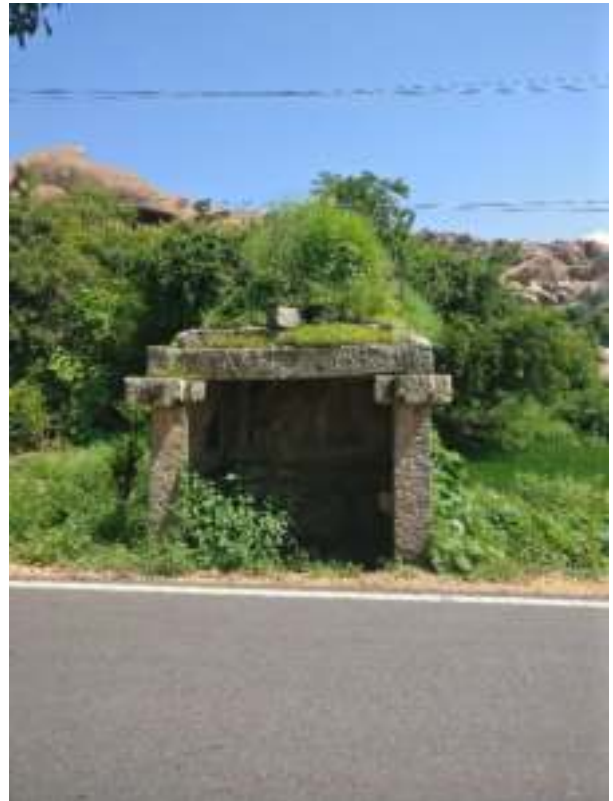
Parts of the shrine has submerged under ground due to the constant raise in road level. Care should be taken to level make them accessible for the visitors.

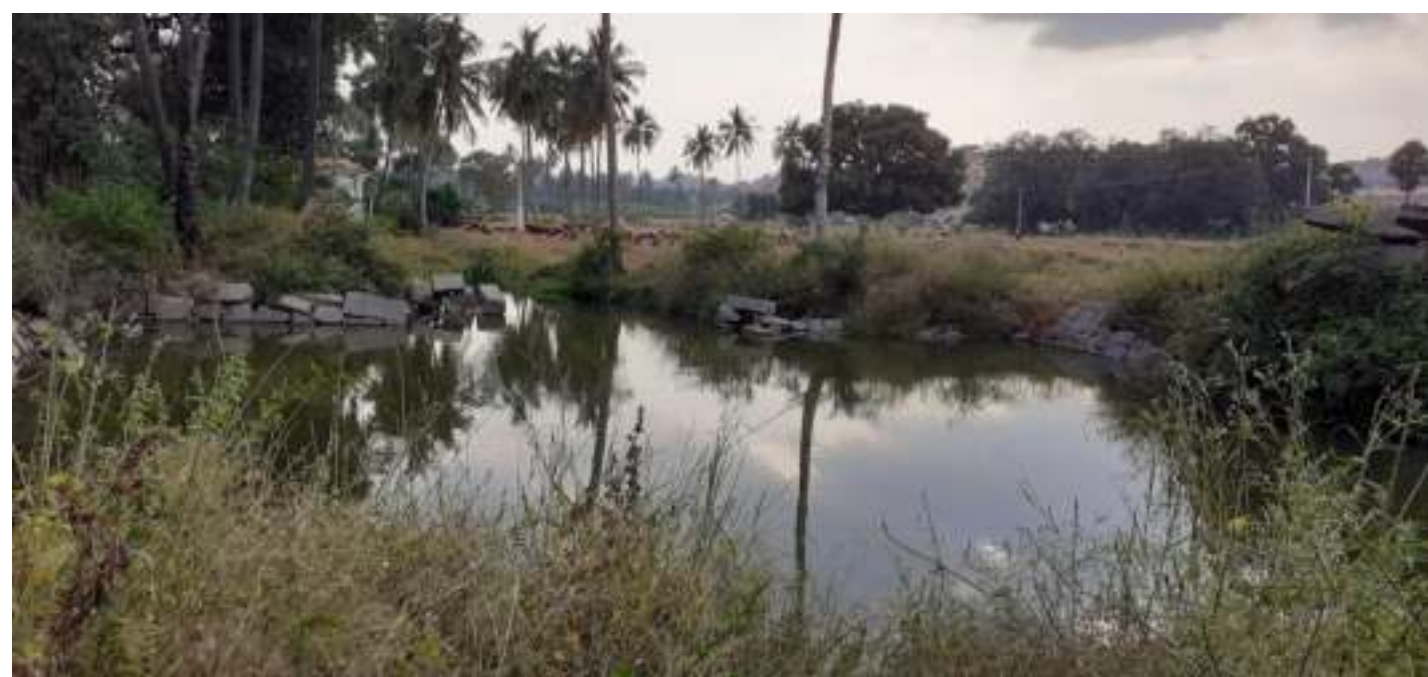
WATER TANK

The retaining stone wall around the tank is in a much dilapidated state; and almost half of the tanks boundary has unwanted weeds growing around it. These shall be cleared and replaced with indigenous weeds that can prevent Soil erosion.

The stone walls needs to be restored and a proper access to be provided from the road.
