Report by INTACH Anegundi Hampi Chapter

CONDITION ASSESSMENT OF SHRINE STREET

SHRINE STREET

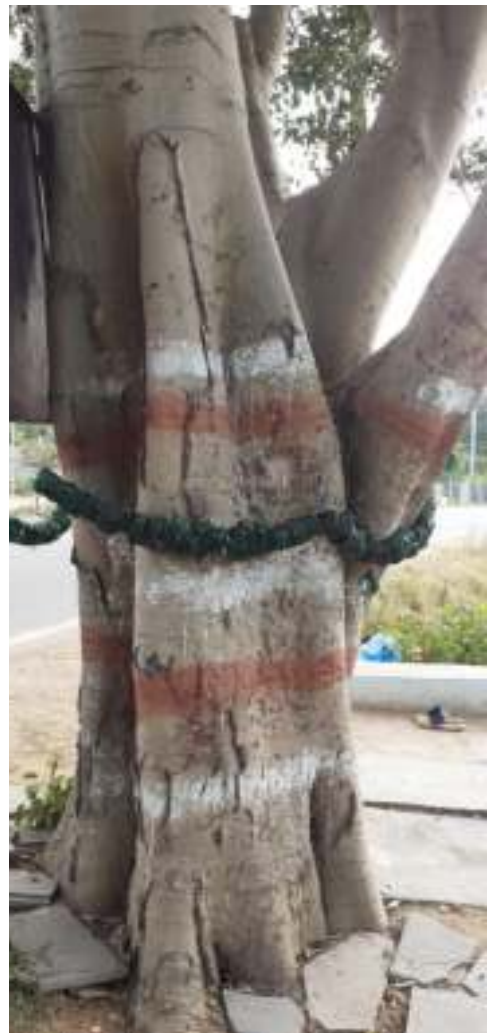
The Peepal tree located at the temple entrance holds a great associational and religious value.

This shall be preserved to emphasize the cultural significance of the temple and its surrounding context.

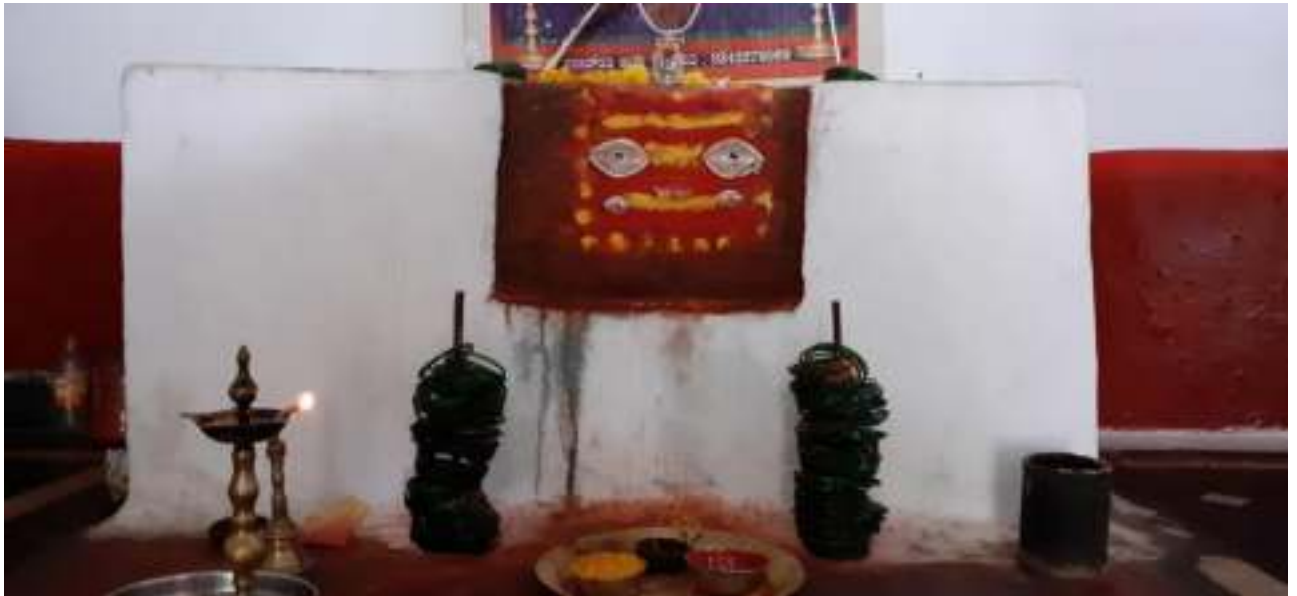
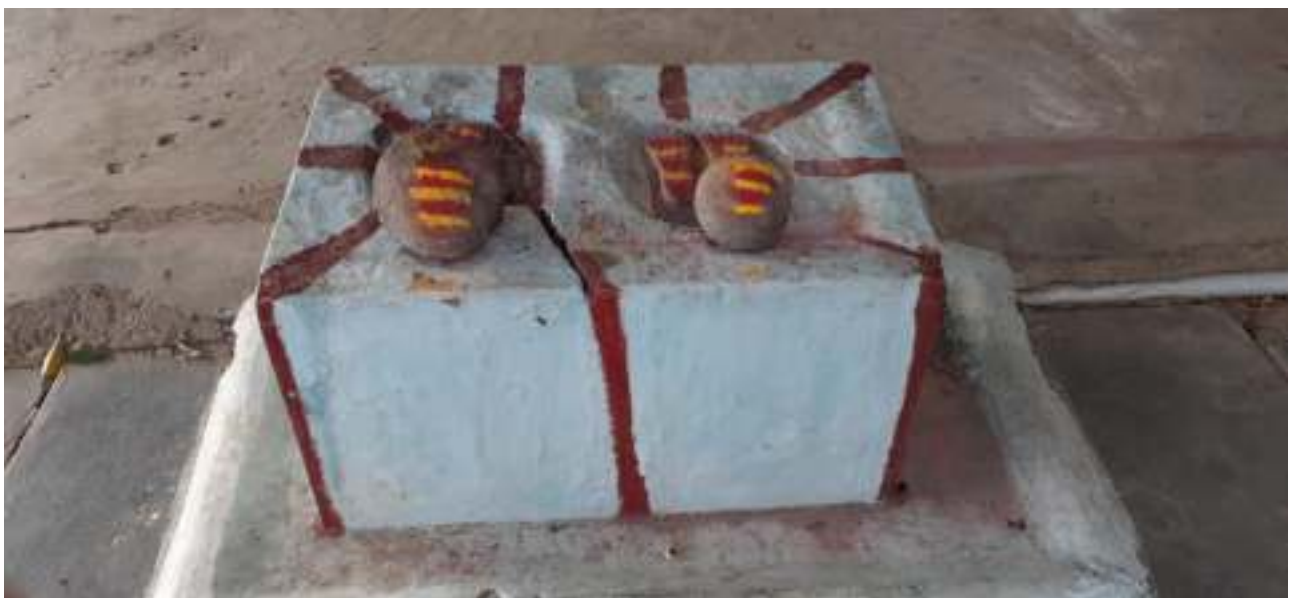
The two stone sculptures inside the Sanctum and the Pada placed at the entrance were said to be in existence ever since the village was formed and holds a great historical and religious significance. Later these were placed under a concrete shelter in 1992, funded by the government. Even the sanctum where Uramma sculpture is placed was constructed in this year.

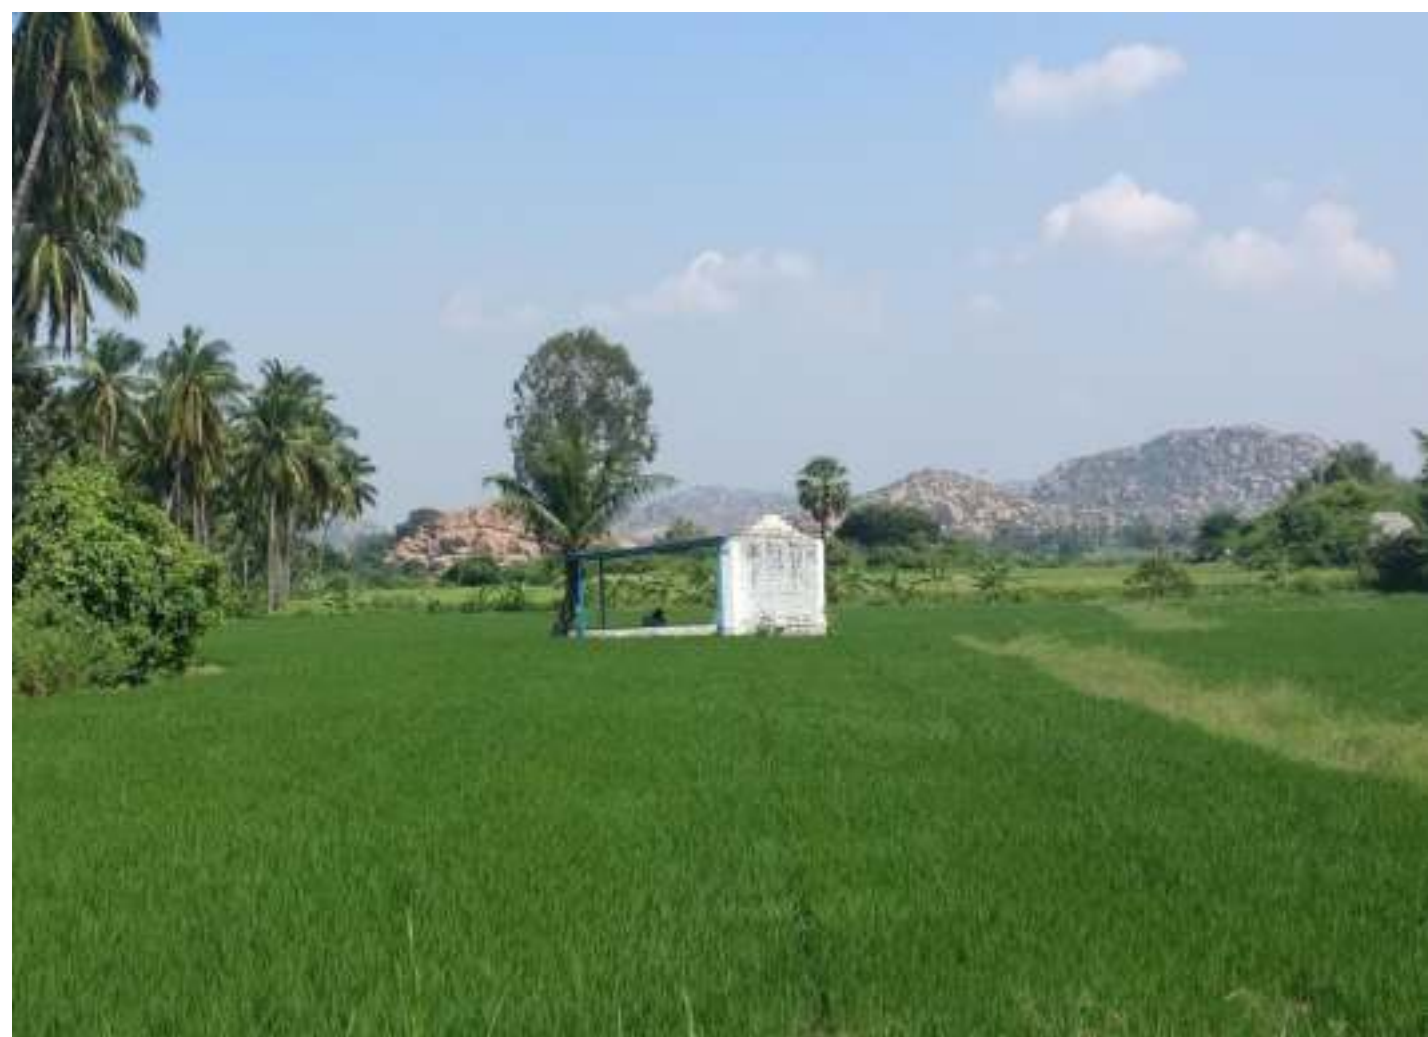
SHRINE 2

This Shrine located to the left of Honna Agasi in the middle of fields is devoid of access and lacks maintenance.

Pathway to be created to making it accessible for visitors and the shrine needs to be core cleaned by removing the paint layers.

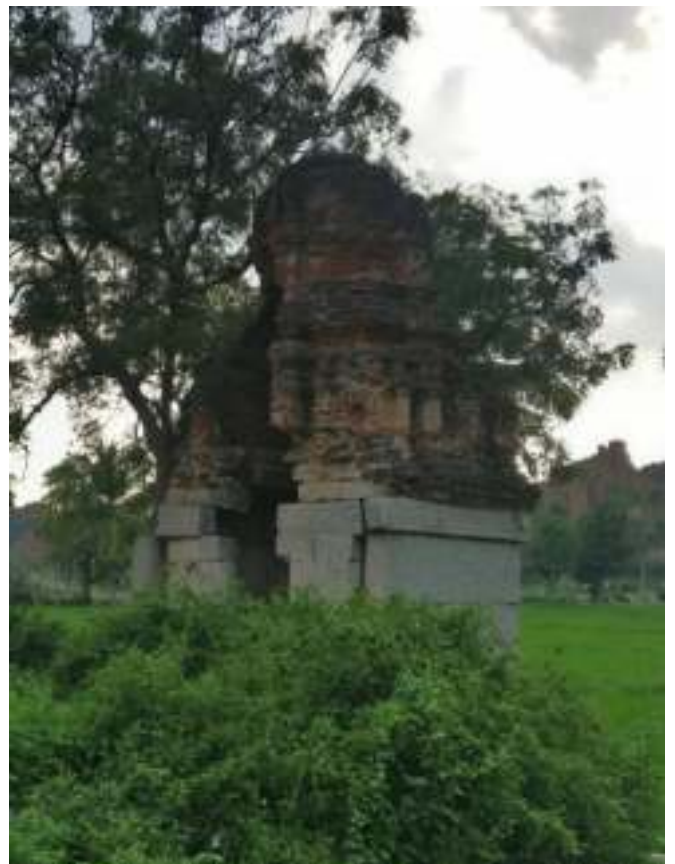
Currently the access to the Shrine is restricted due to hap hazardous vegetation growth, that needs to be cleared and made easily accessible for the visitors.

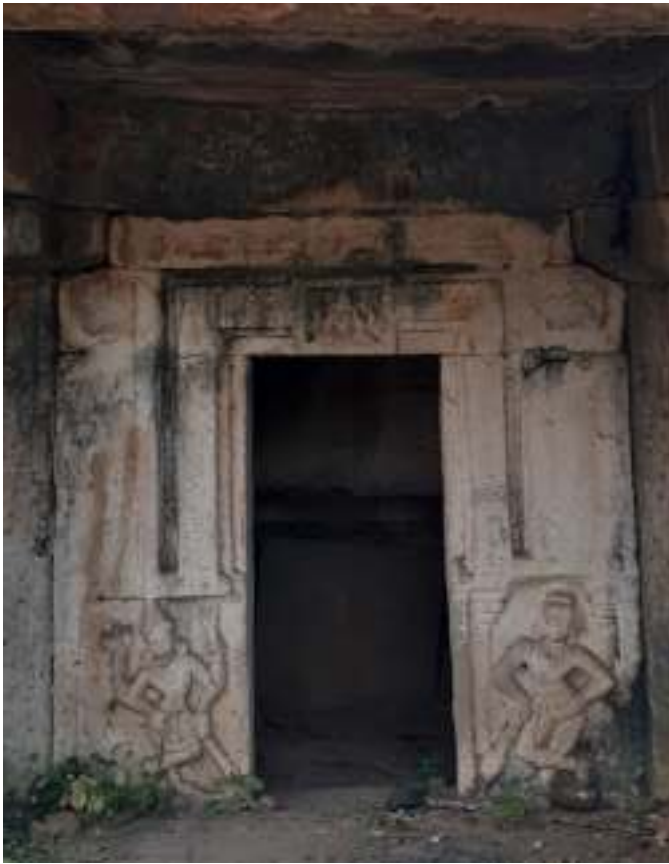
The ceiling of the shrine is deteriorated due to the penetration of dampness from roof, that has led to salt deposition.

Measures to be taken for the removal of dampness and salt deposit as well as arresting the source of dampness and applying a layer of damp-proof coat over the surface.

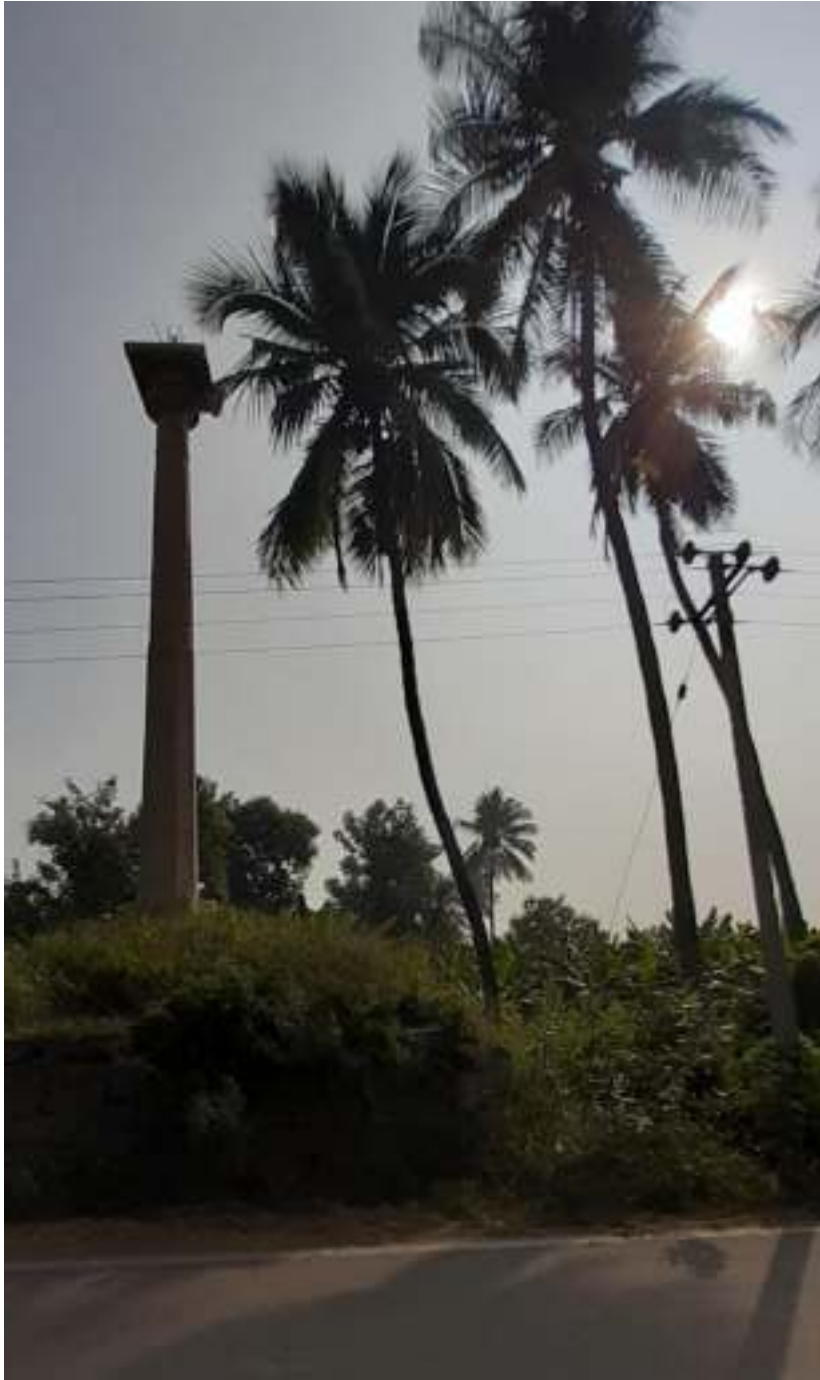
DEEPA STAMBA

The Stamba has been restored and is devoid of any structural issues. But the platform over which the Stamba stands is in a dilapidated state and is covered with vegetal growth.

Care should be taken to clear all the vegetation and restore the platform.

Bushes around the platform also needs to be cleared with an appropriate landscape designed to signify the monument.

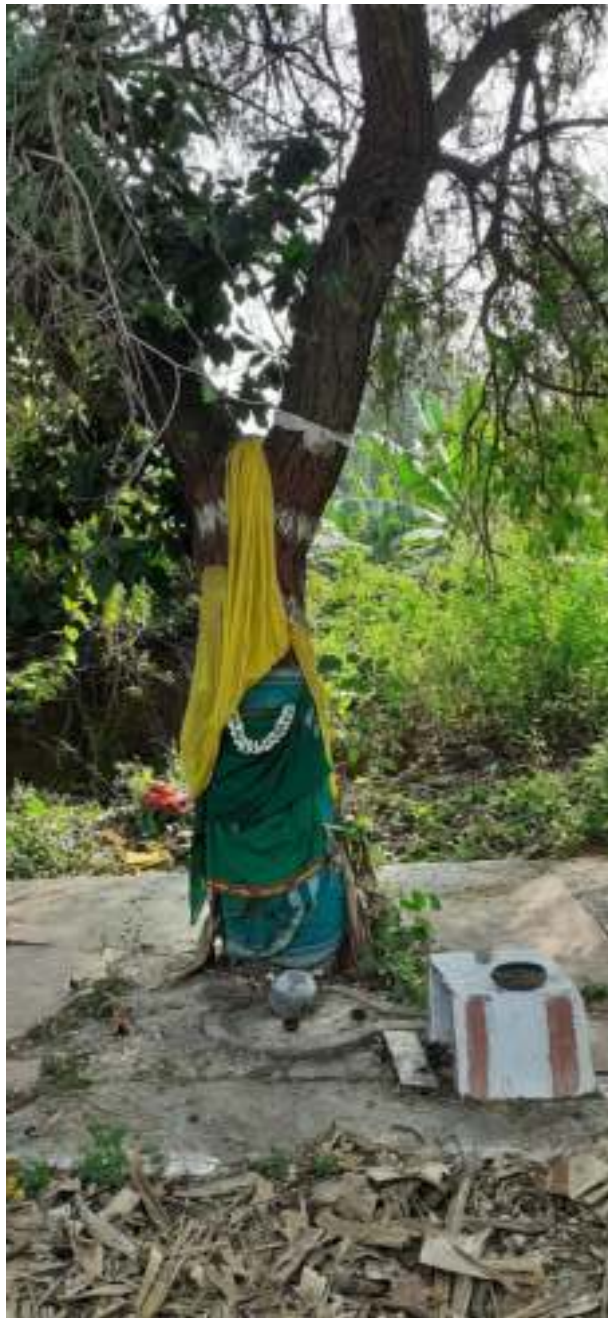
SACRED TREE

The Sacred tree opposite to the Naga Shrine is significant due to its religious and cultural values.

The platform needs to be maintained with an appropriate landscape that shall embrace its values.

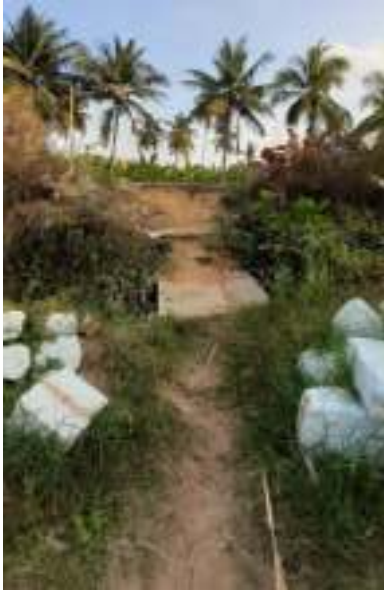
The pathway leading to the shrine lacks maintenance and needs to be re-designed to make it easily accessible for the visitors.

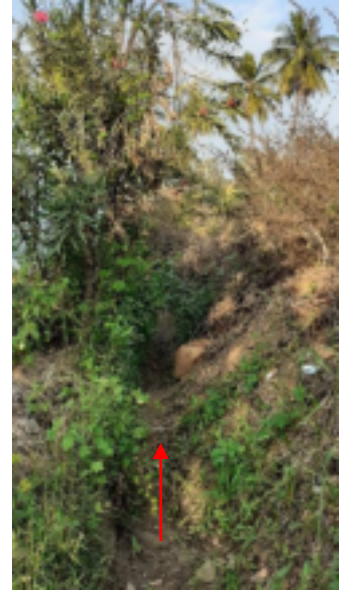
View of the water channel across the pathway- that needs to be restored and maintained intact.

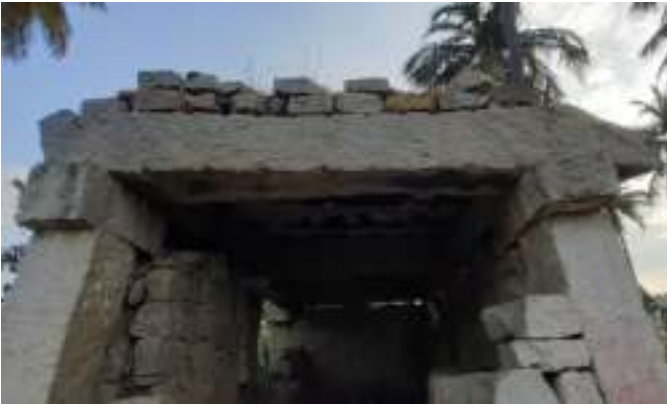
ROOF

The stone masonry on the roof is in a dilapidated state leading to the growth of Vegetation. Care must be taken to remove the Vegetation and restore the roof structure, covering it with a damp-proof coat.
